Meditating After Mege 2018 Conference and Site Visit: Geohazard and Damages To Zipingpu Reservoir Induced by Wenchuan Earthquake in China

**Mege 2018会议和实地考察后的沉思：
中国汶川地震引发紫坪铺水库的地质灾害和破坏**

By Ir. Raymond S. M. Chan 陈顺明

4 Geohazards and Damages Towards Zipingpu Dam 紫坪铺大坝的地质灾害和危害

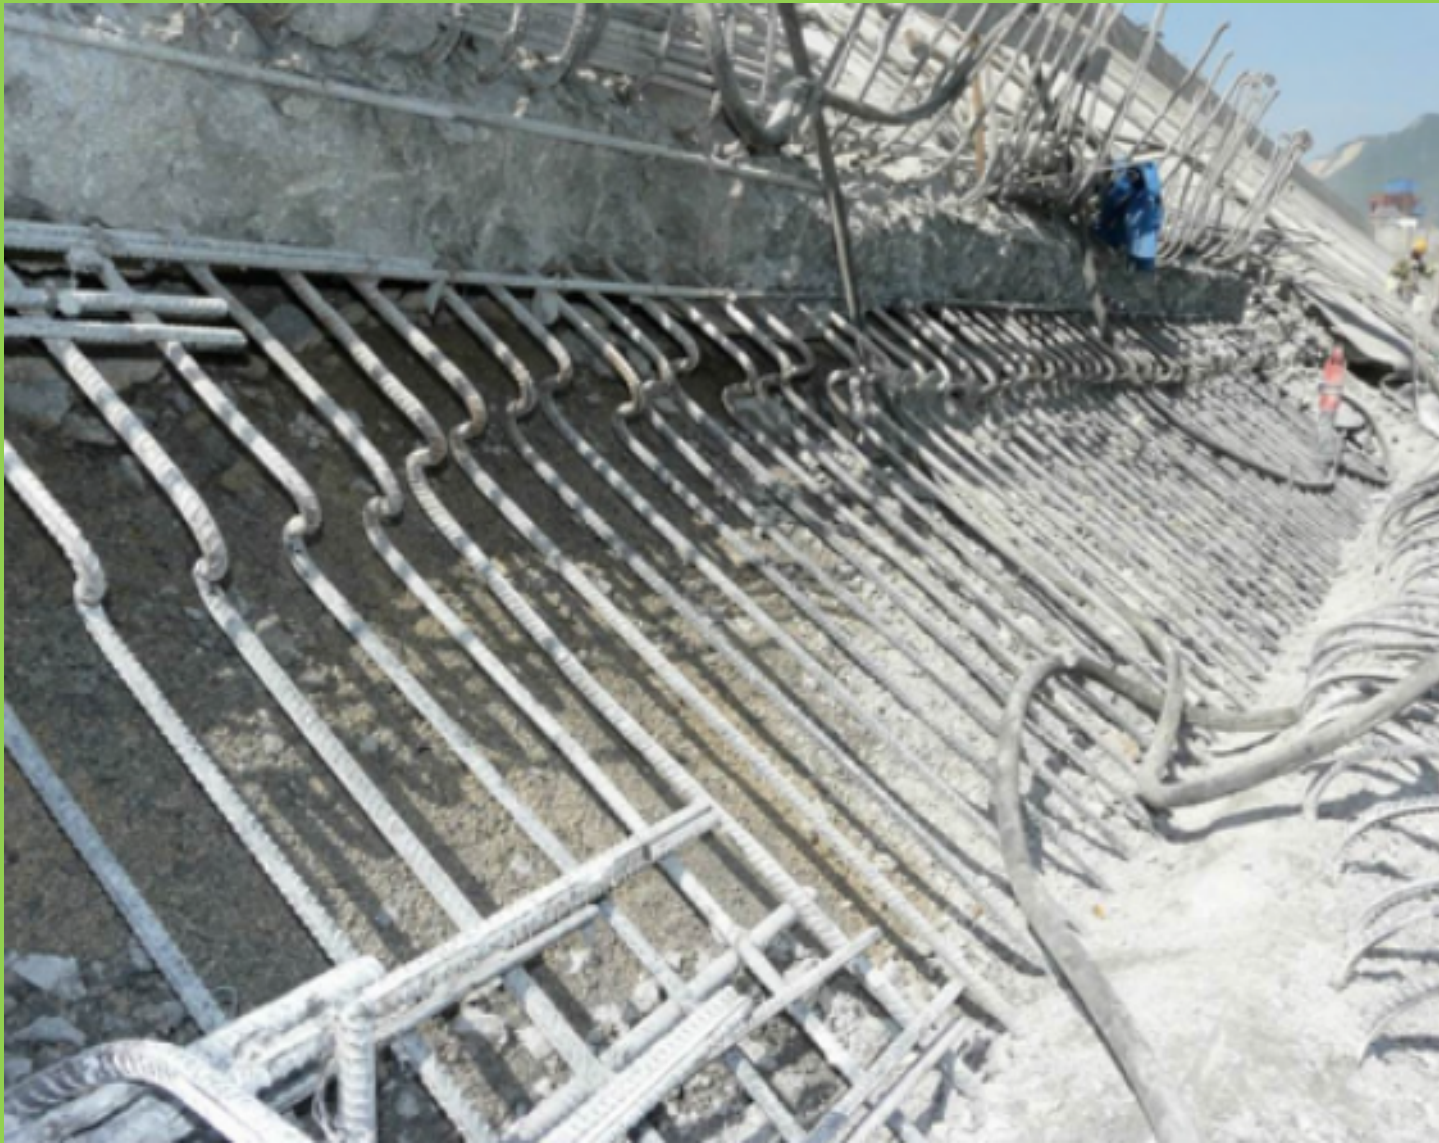
Dislocation damage observed after cleaning the damaged concrete
清洁损坏的混凝土后观察到位错损坏

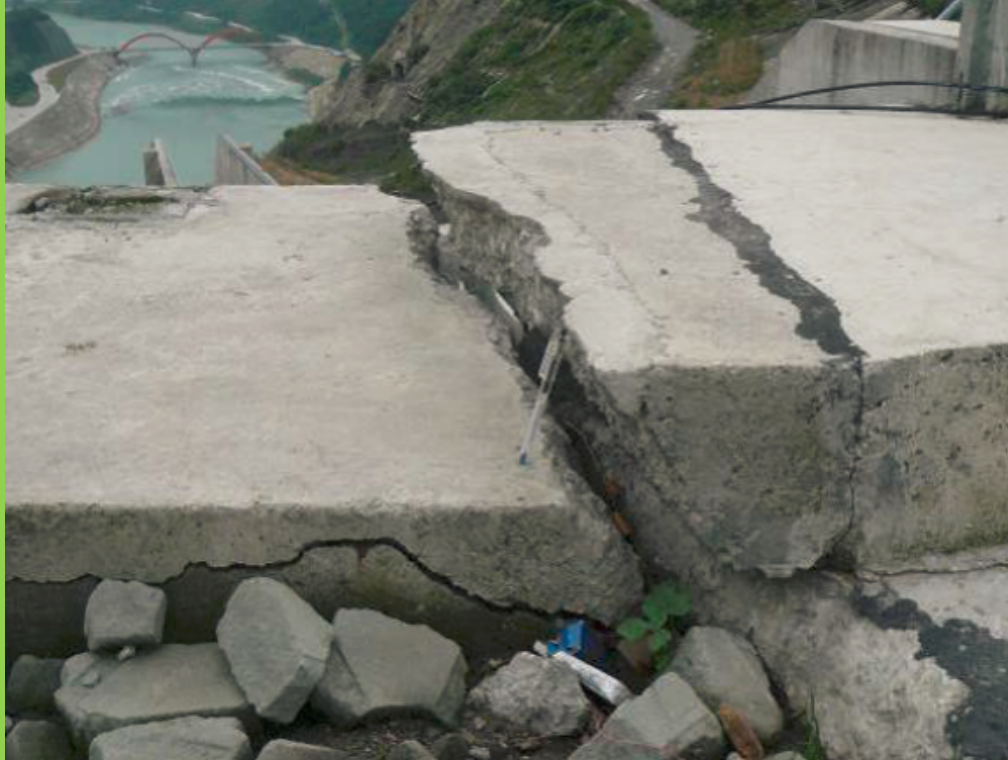
The top of the reservoir was affected by the earthquake, and the left side of the photo was about 15 cm from the right side

水库坝顶受地震影响，照片左侧相对右侧陷落约15公分。

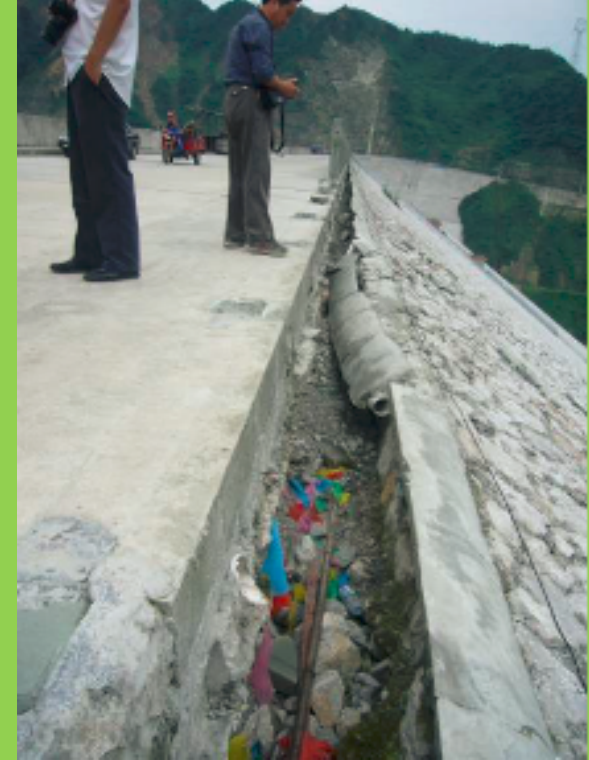
The outer dam of the top of the reservoir lands on the downstream backwater slope. The dam is about 70 cm below the center and about 30 cm outside the downstream.

水库坝顶外侧护欄震落于下游背水坡面，大坝中央下陷约70公分，向下游面外移约30公分。

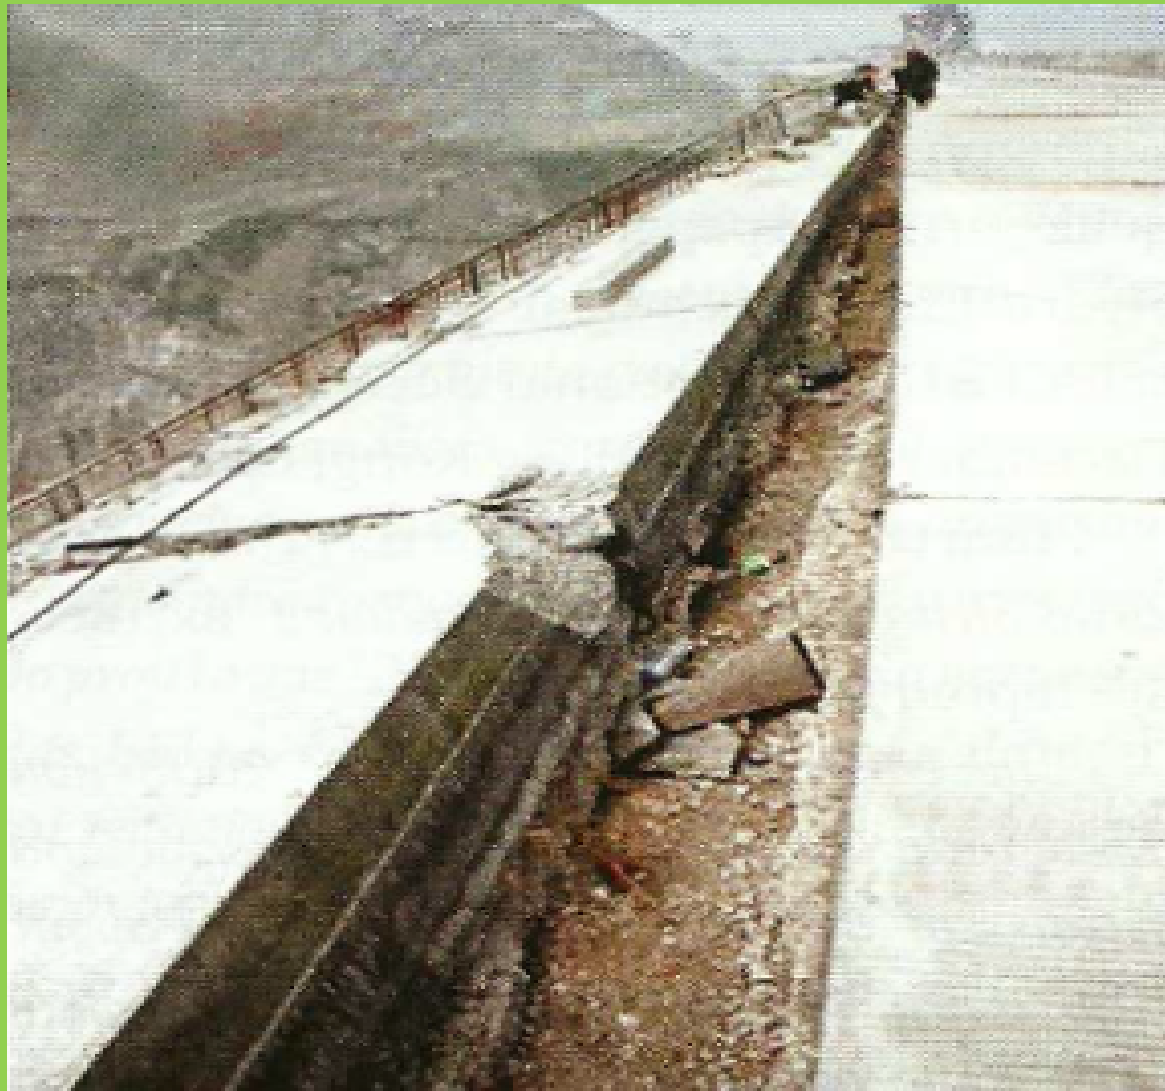
Displacement of access way and the crest of Zipingpu Dam

-This measured up to 630mm

紫坪铺水库进出通道和顶部的位移—最大达630mm

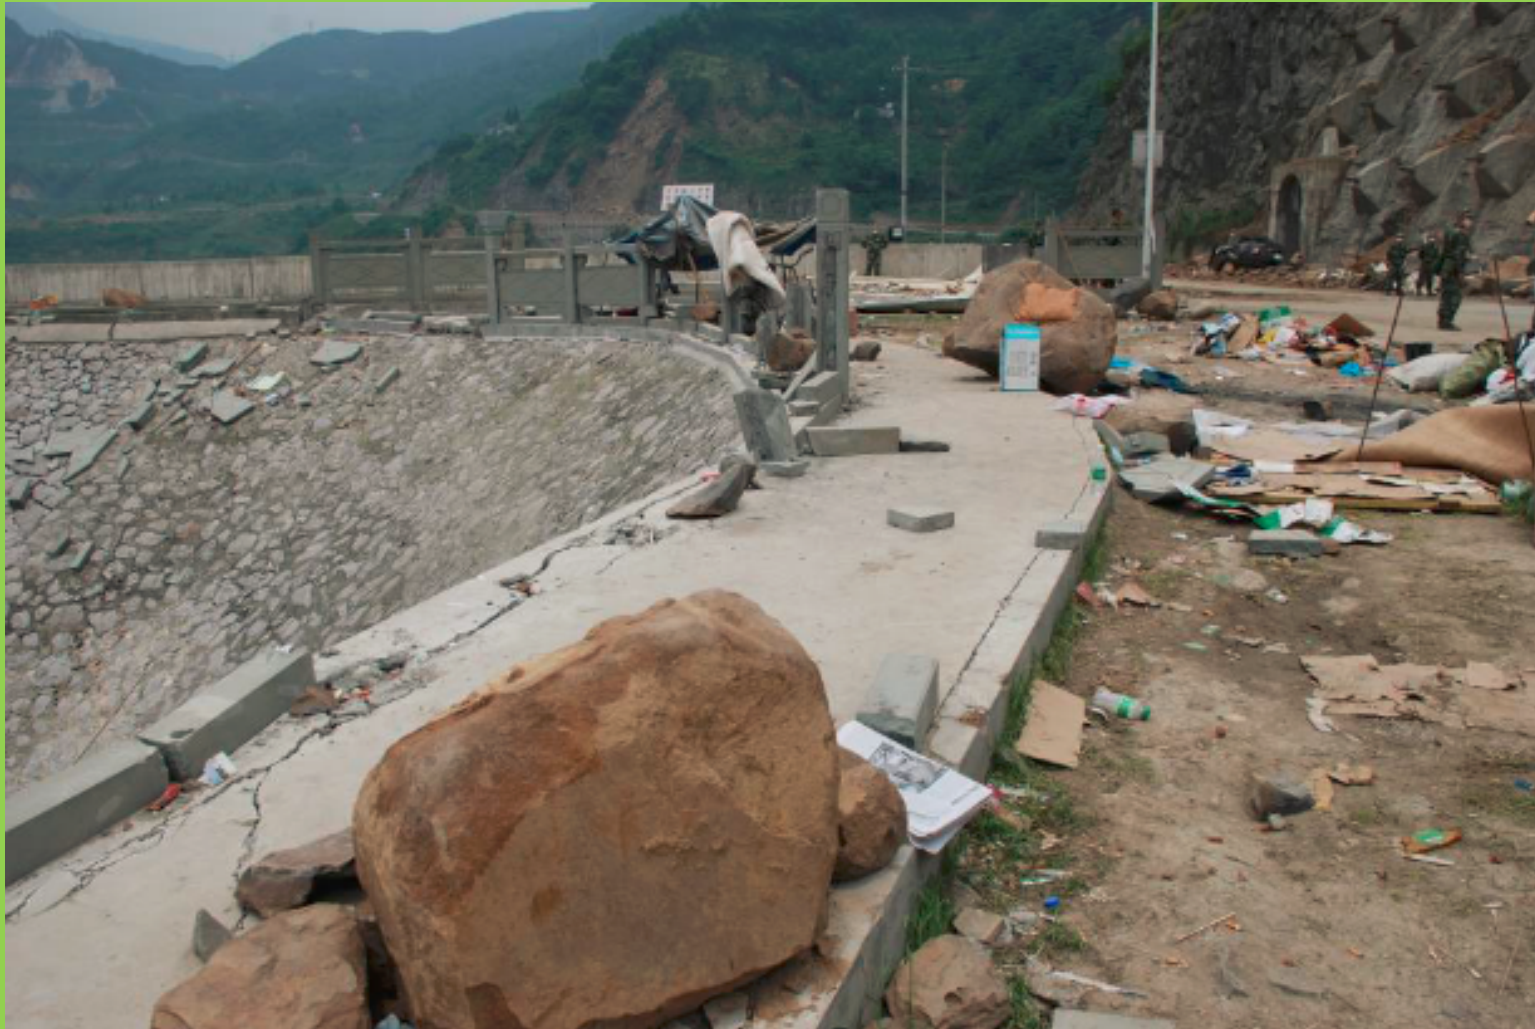
View of landslide boulders from the left slope of the abutment on the dam crown. $31^{\circ} 02' 08,89''$ N – $103^{\circ} 34' 40,81''$ E

从坝顶桥台的左坡看滑坡巨石。 $31^{\circ} 02' 08,89''$ N – $103^{\circ} 34' 40,81''$ E

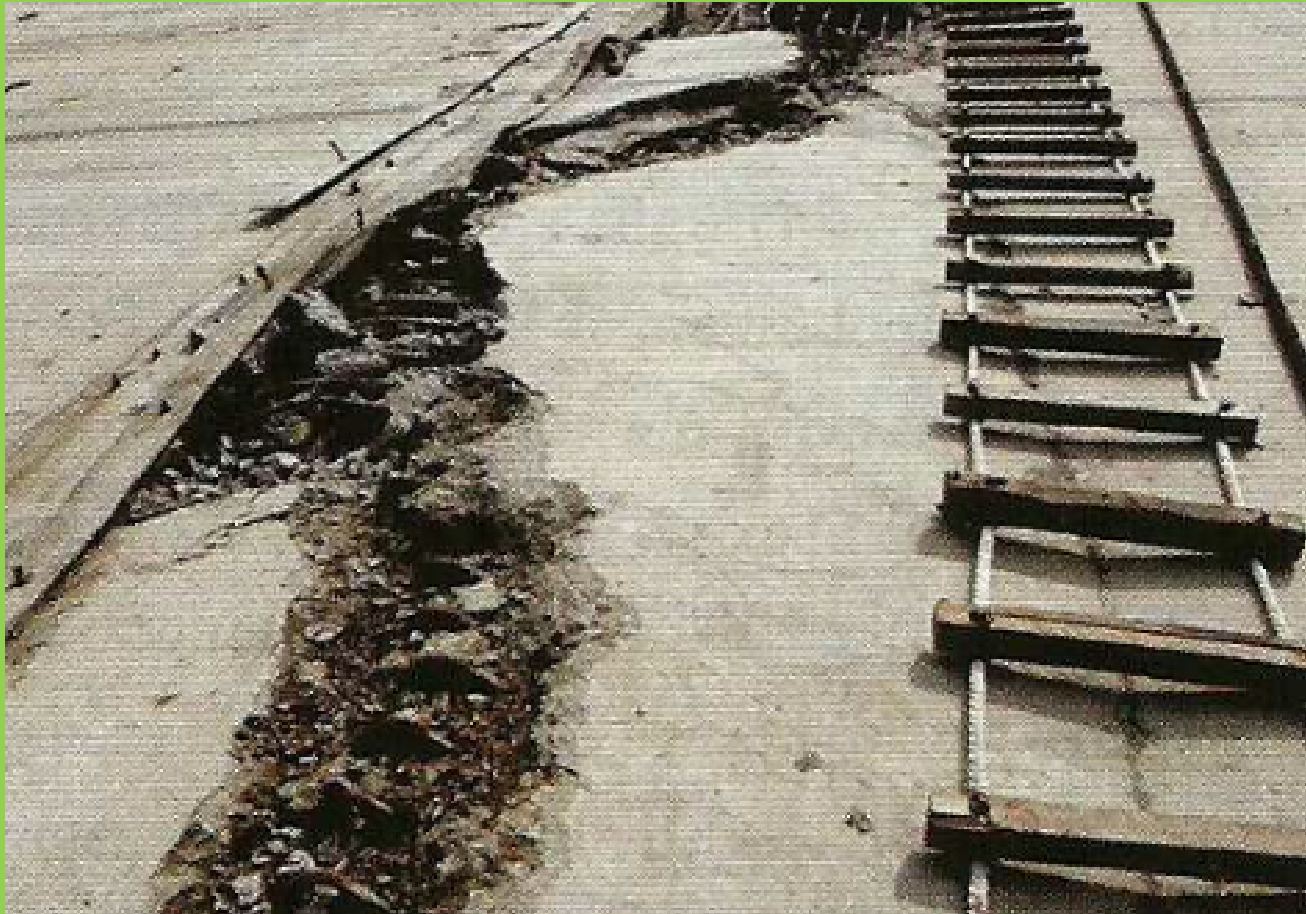
Compressive failure of Slab No. 23 and 24 at the central parts of Zipingpu Reservoir

紫坪铺水库中部23、24号板受压破坏

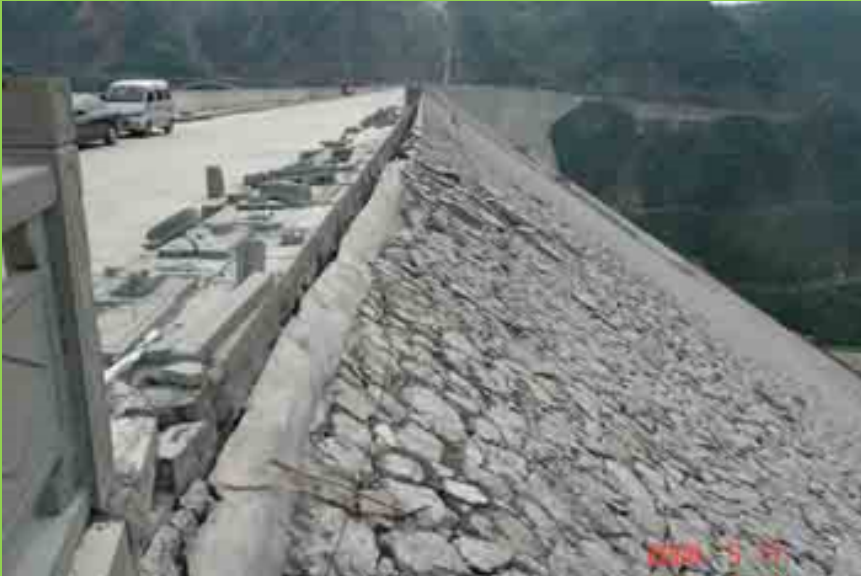
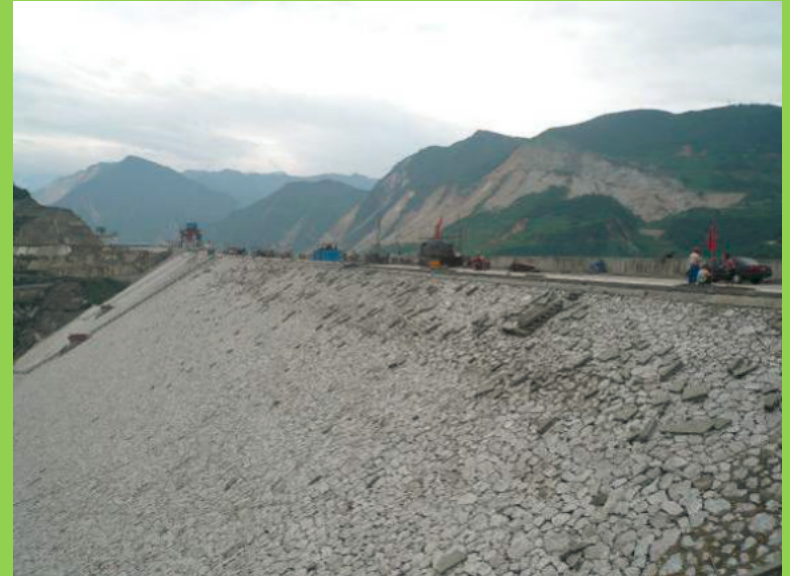
The outer guard of the dam crest of Zipingpu Reservoir was shaken by earthquake and fallen to the downstream of the backwater slope

紫坪铺水库坝顶外护栏受地震震动，倒塌至回水坡下游

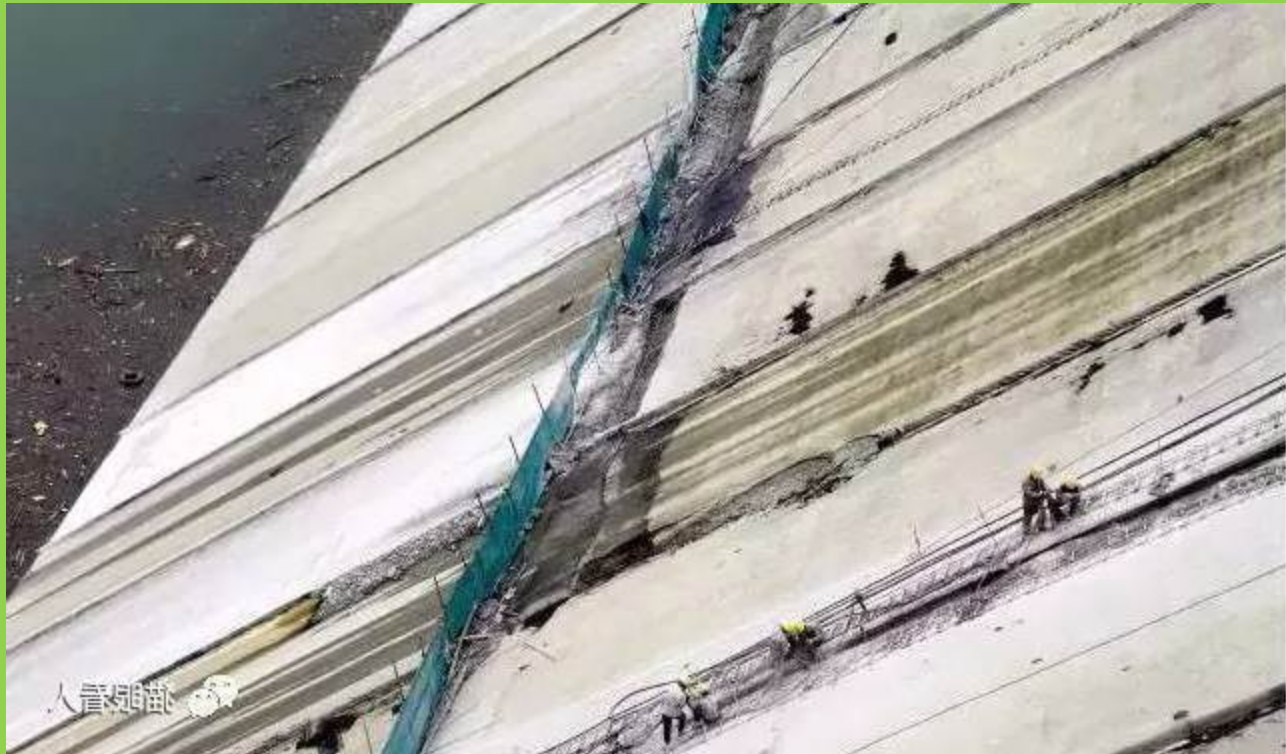
On May 12, 2008, the dam of the Zipingpu Reservoir on the Minjiang River, which was damaged and formed a huge crack in the Wenchuan earthquake.

2008年5月12日，汶川地震中遭受破坏、形成巨大裂缝的岷江紫坪铺水库大坝。

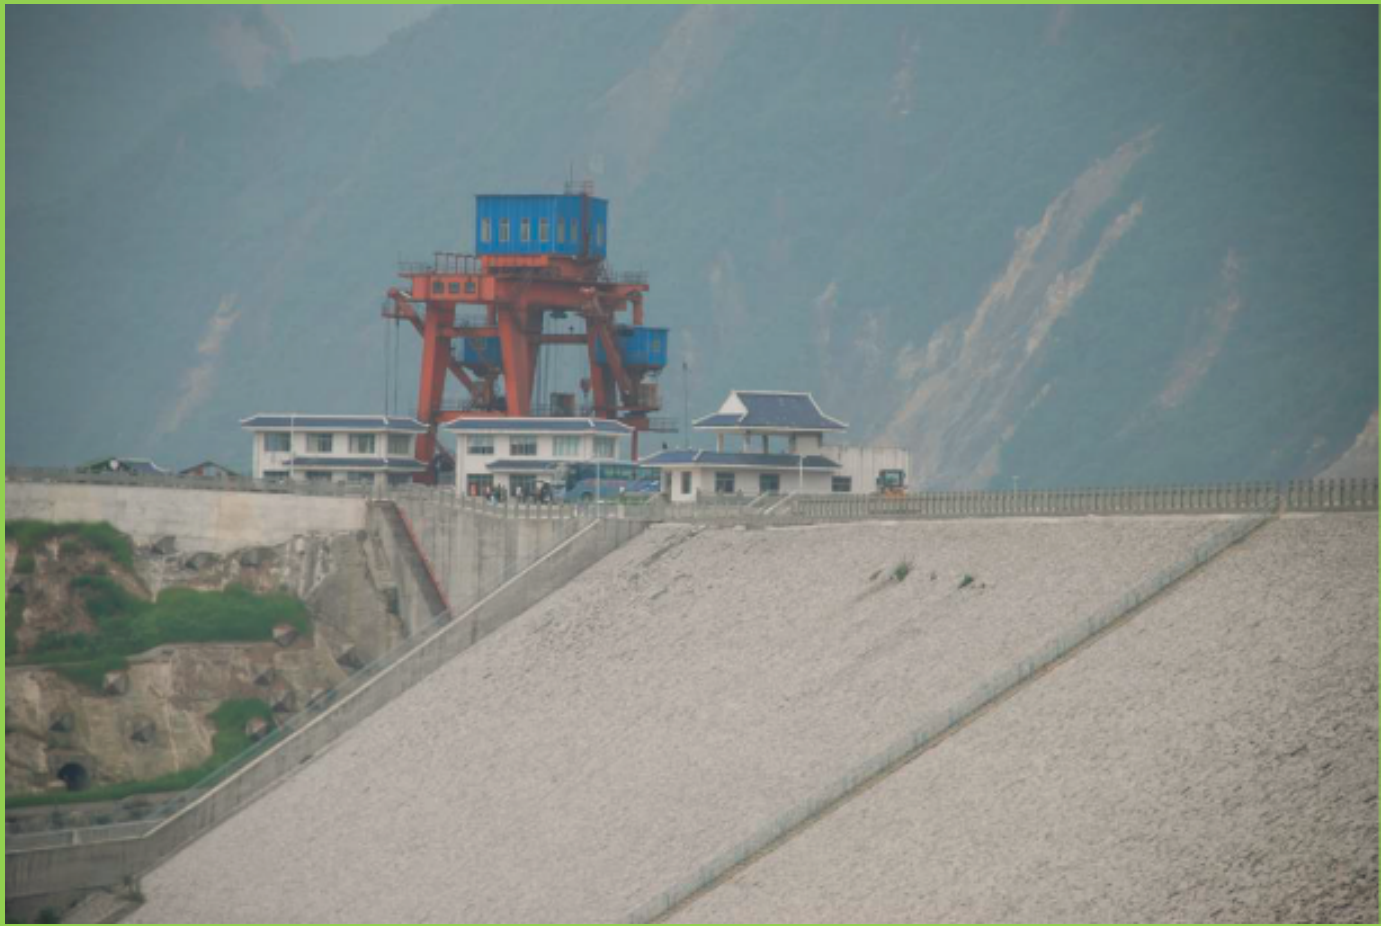
Vertical fractures on the right side of the dam axis due to differential subsidence of the dam body in relation to the rigid section of the emergency spillway. 31° 02' 08,21" N – 103° 34' 18,42" E

坝体右侧的垂直裂缝是由于坝体相对于应急溢洪道刚性段的不同沉降造成的。31° 02' 08,21" N – 103° 34' 18,42" E

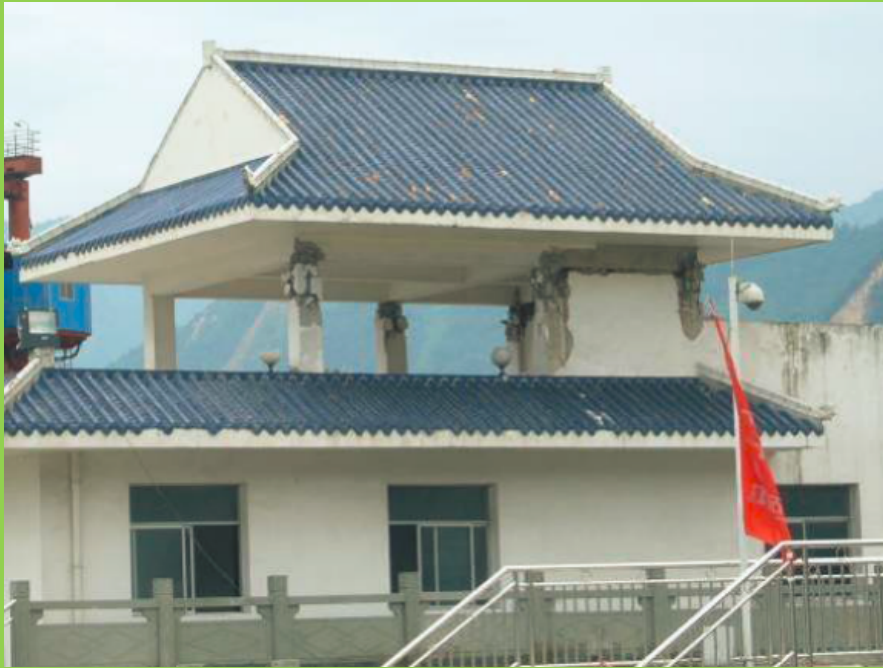
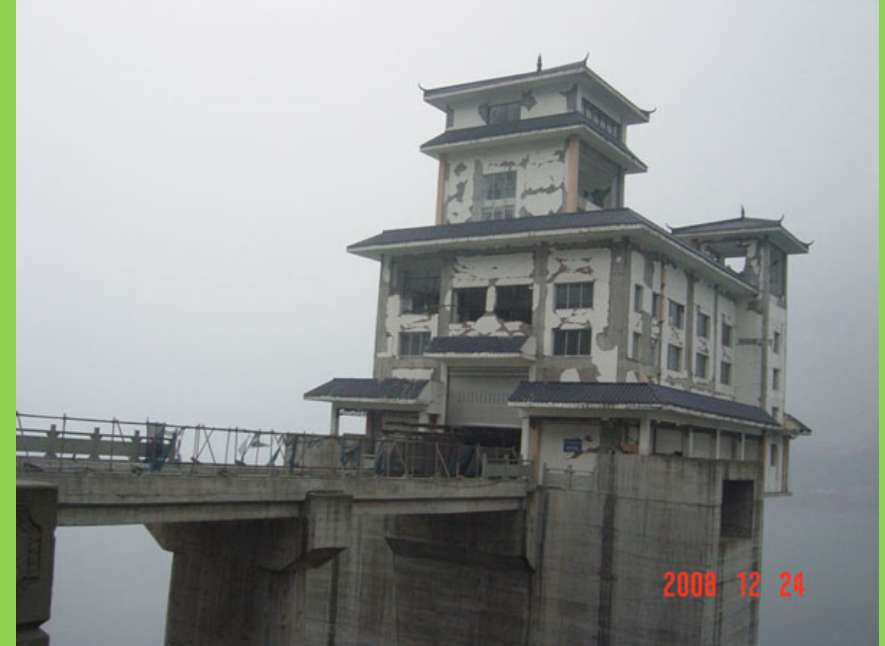
**The roof of the buildings on crest of the reservoir
was damaged by seismic shearing
水库坝顶房舍受地震剪力作用导致结构受损**

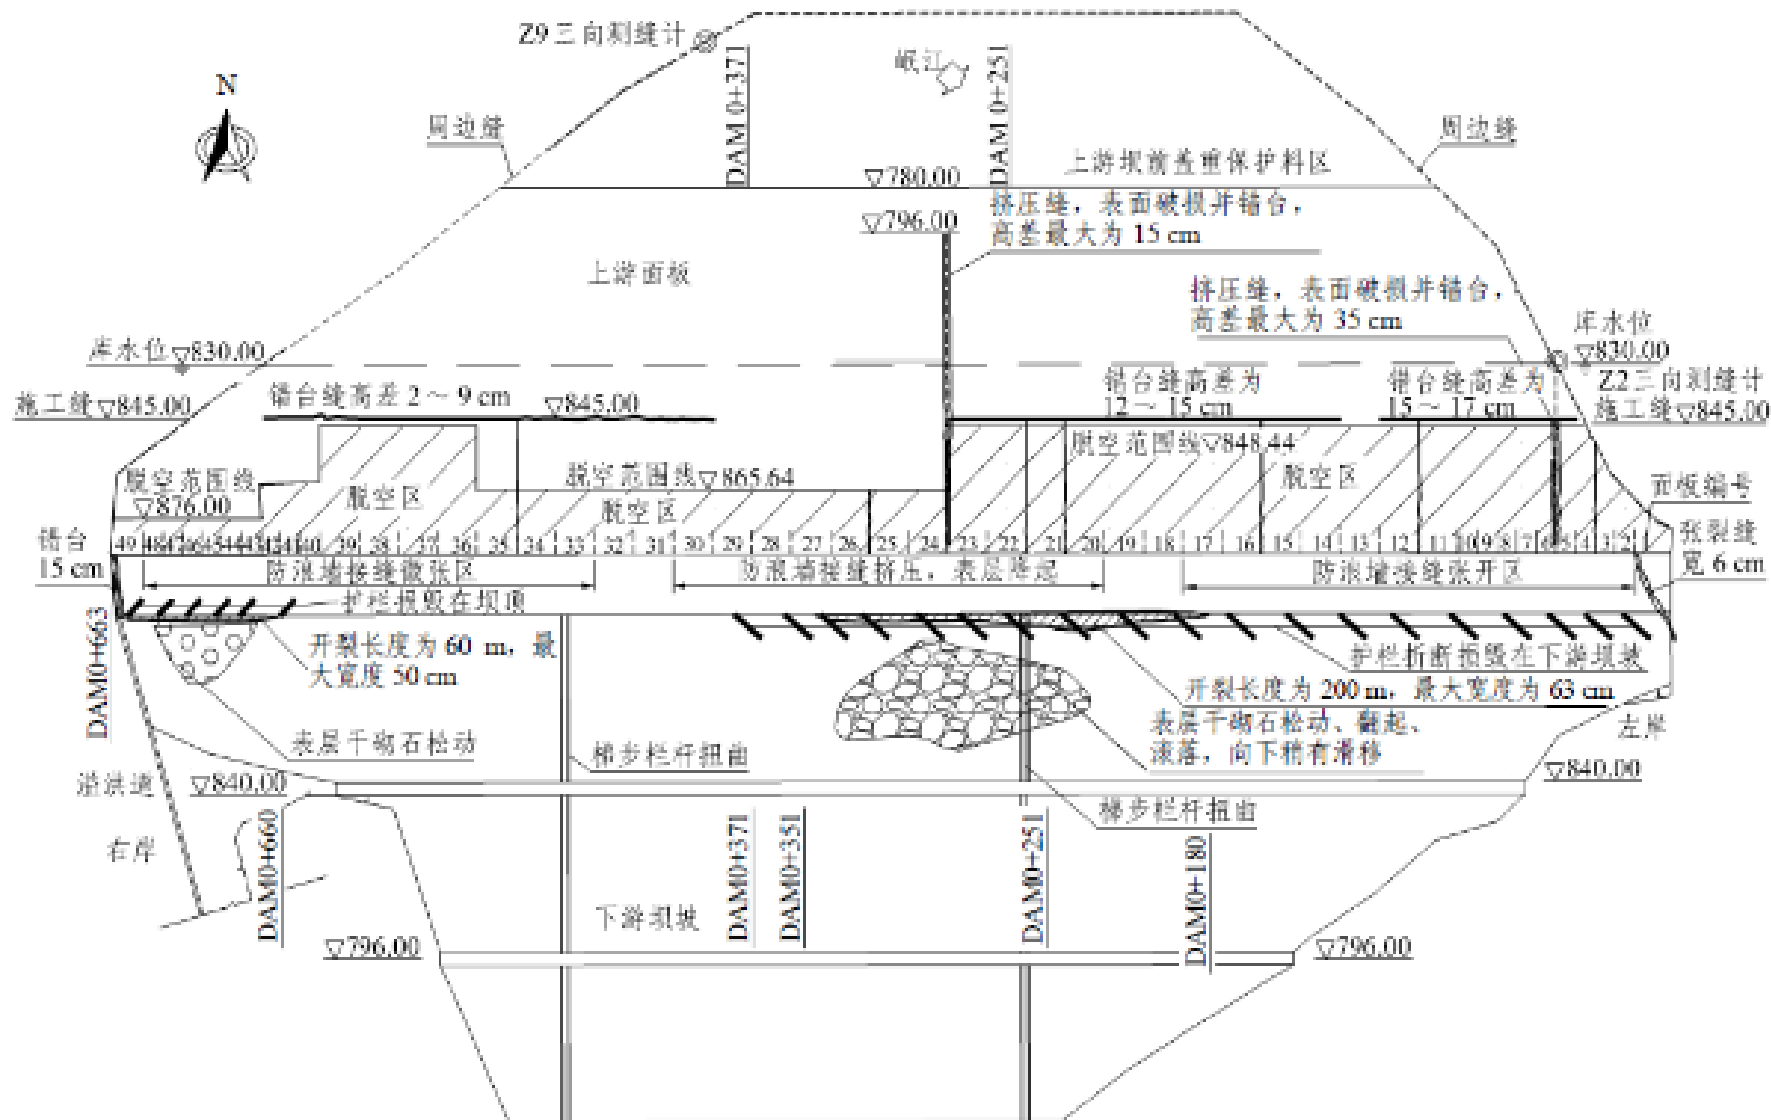
Macroscopic earthquake damage distribution of dam(unit of elevation: m)

大坝工程宏观震害现象分布示意图(高程单位：m)

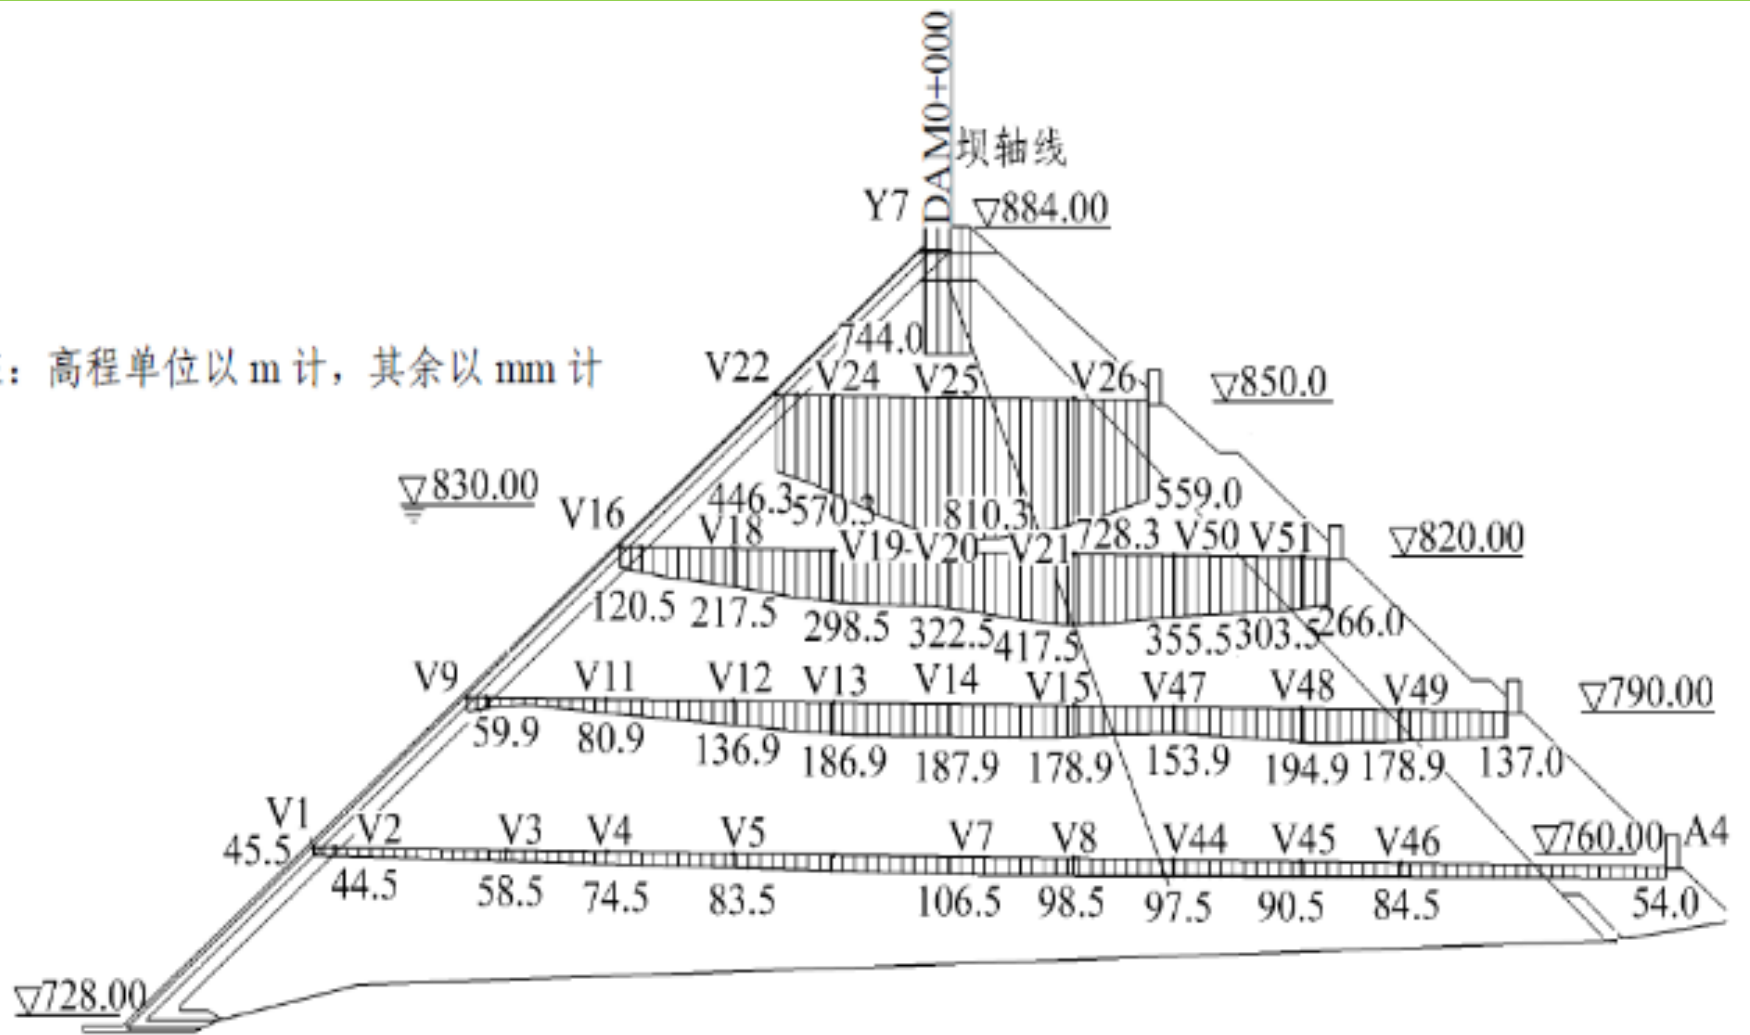
Settlement distribution at dam section 0+371

0+371坝段沉降分布

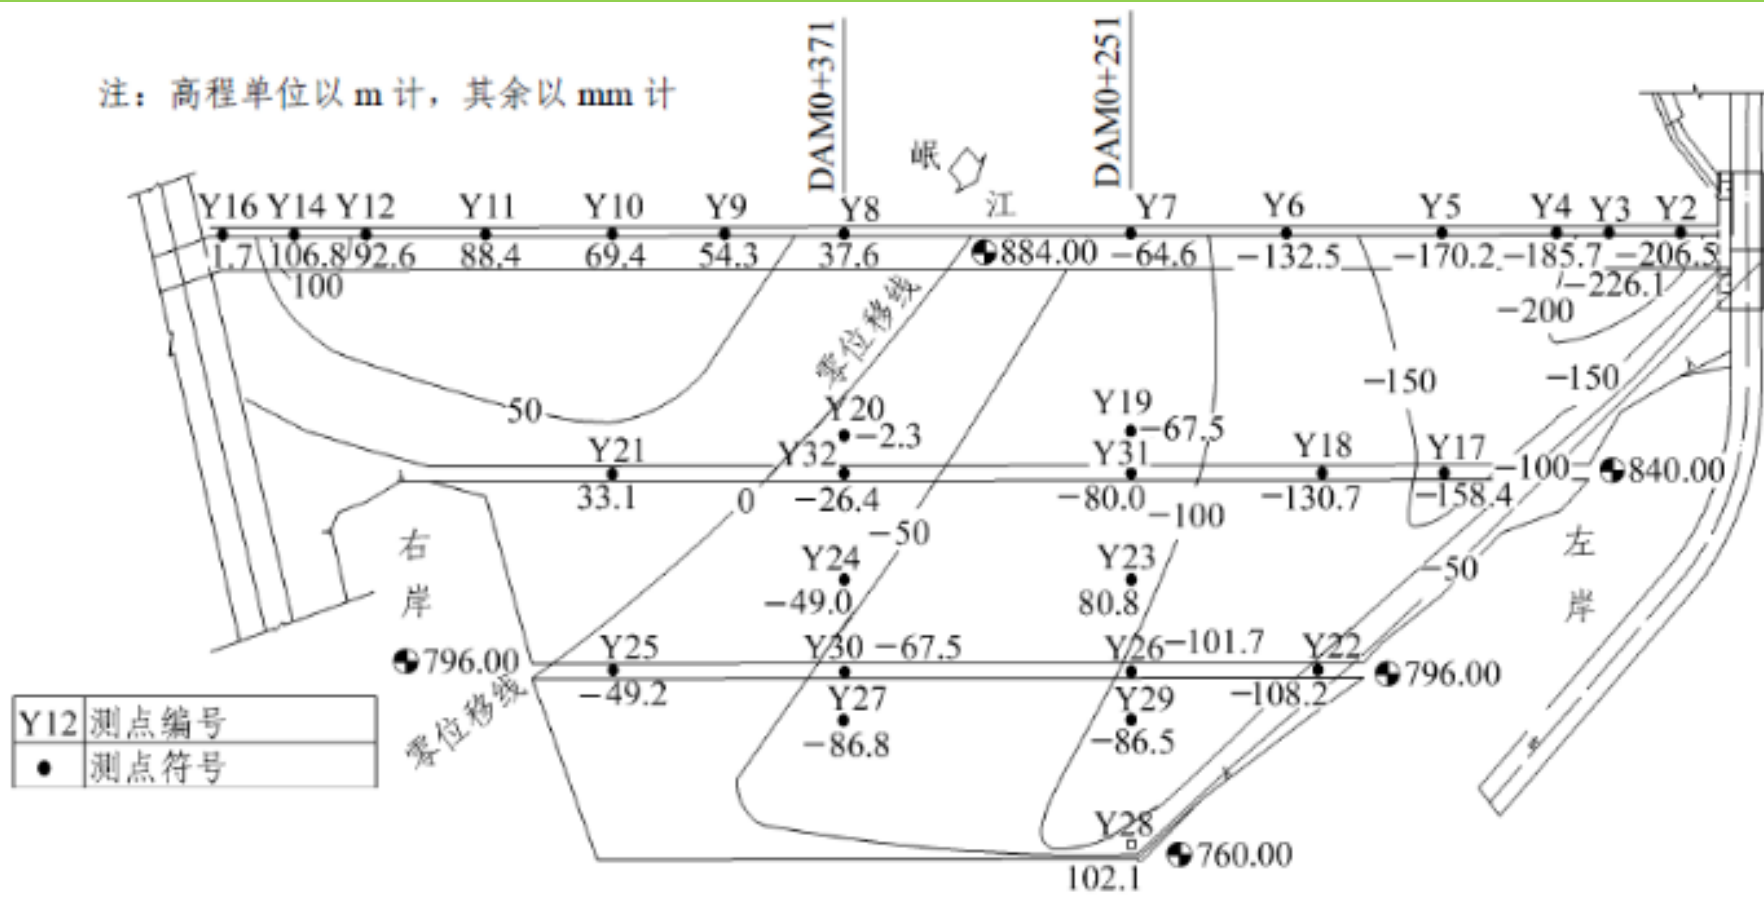
Contour lines of horizontal displacement parallel to dam axis at dam crest and downstream slope (displacement toward left bank is positive)
 坝顶和下游坝坡平行坝轴线水平位移分量等值线(向左岸位移为正)

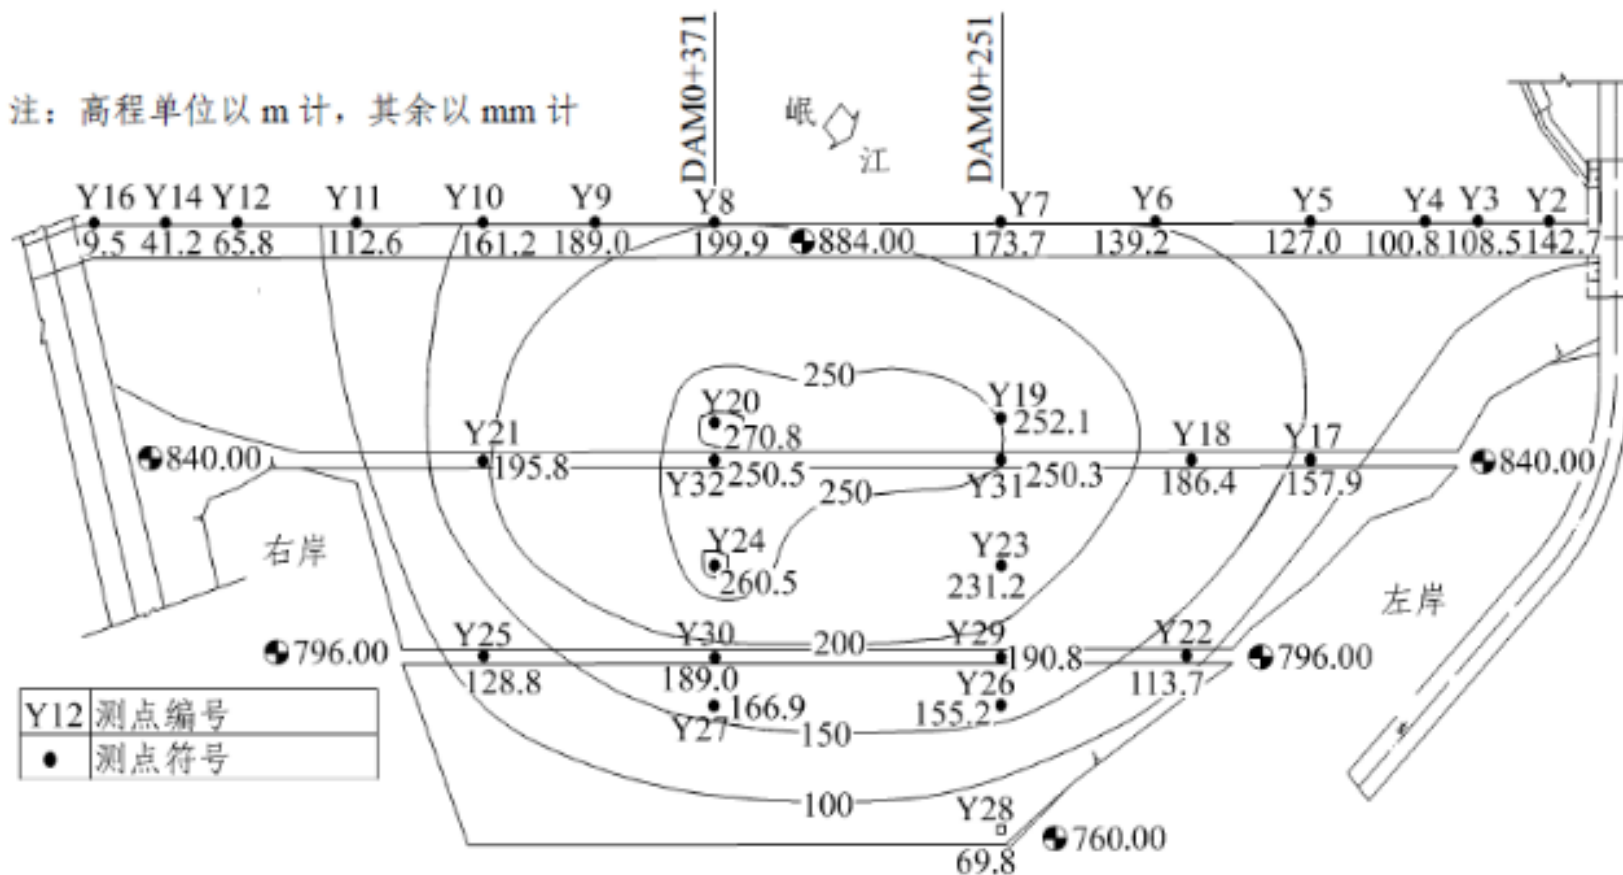
Contour lines of horizontal displacement perpendicular to dam axis at dam crest and downstream slope(displacement)
坝顶和下游坝坡垂直坝轴线水平位移分量等值线(向下游位移为正)

The permanent settlement and horizontal deformation at Zipingpu dam in the pre-earthquake period were 200mm and 80mm respectively. If the permanent deformation at pre-earthquake period is considered, the earthquake induced permanent settlement or deformation would be reduced obviously.

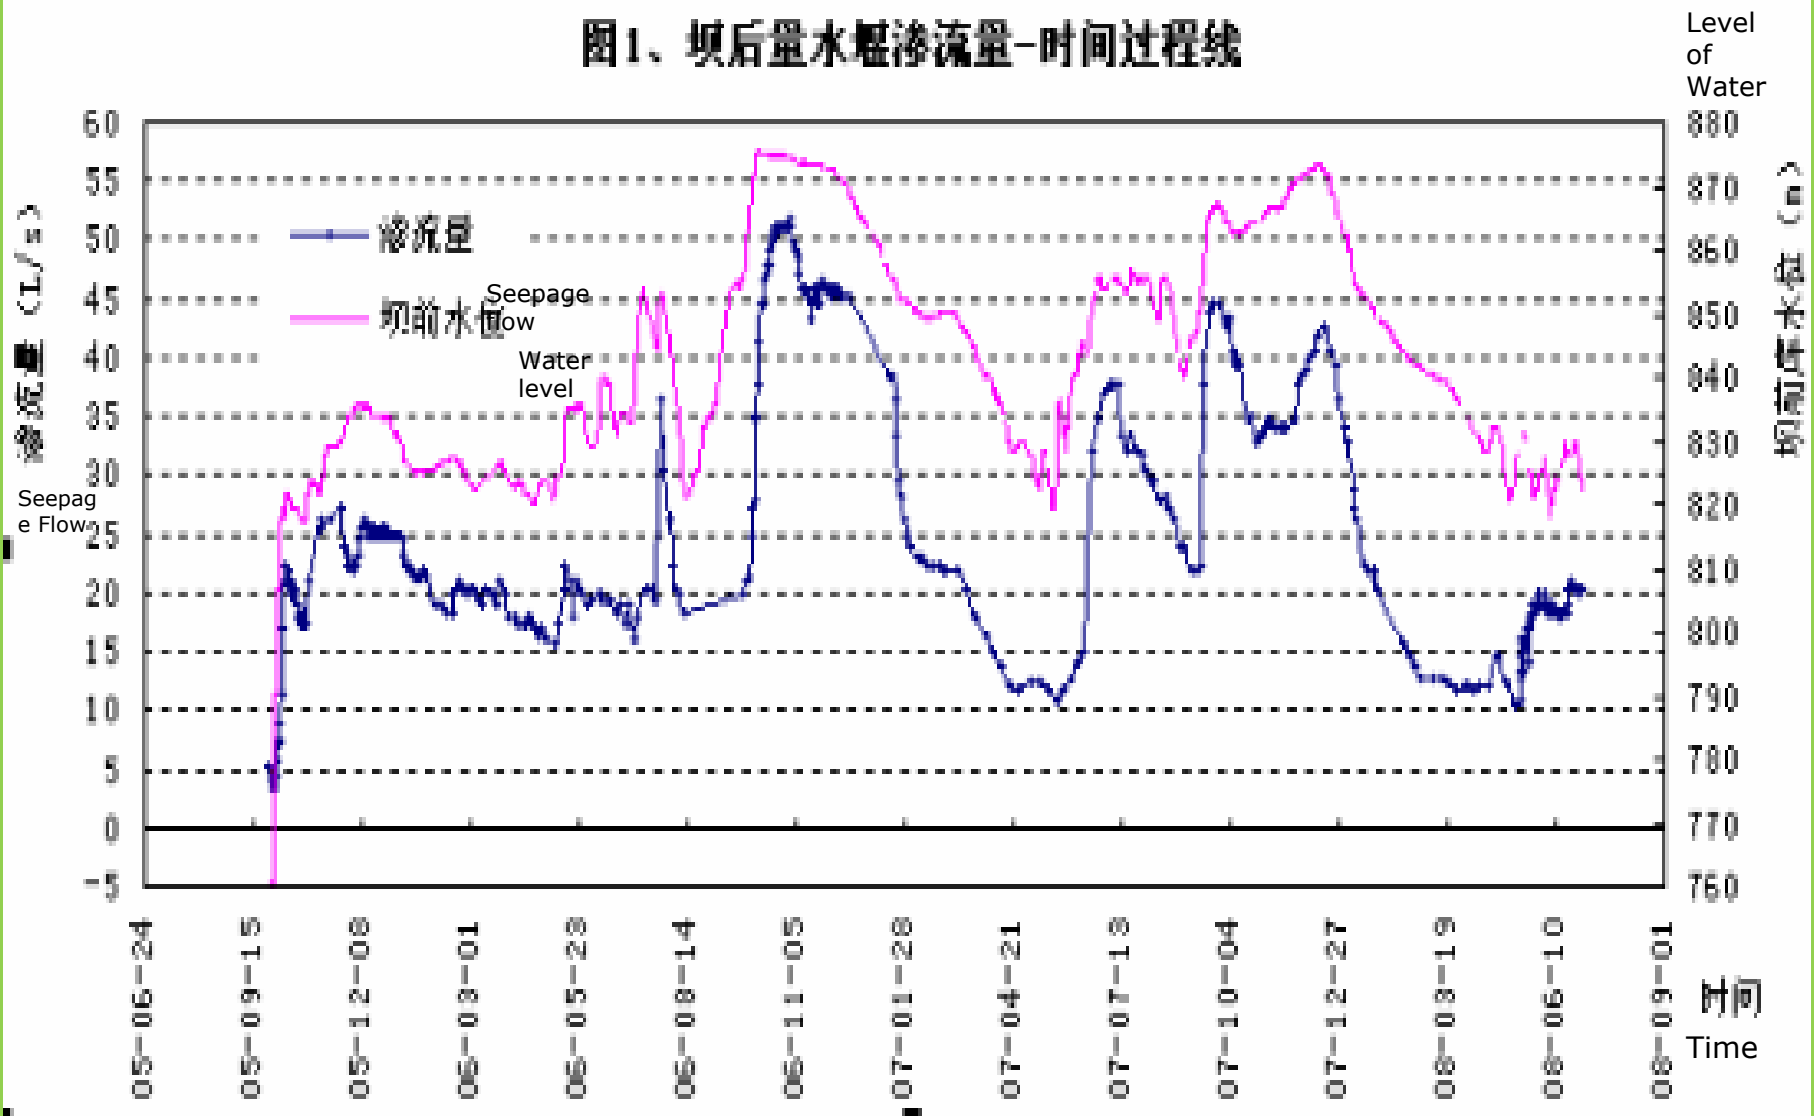
It may be caused by fissure water generated by earthquake-activated bedrock fissures. Due to the earthquake, the original joint fissures in the rock formation at the dam site will be vibrated and dislocated, resulting in the opening, enlargement, dislocation and penetration of the joint fissures of the original rock formation, forming a seepage channel, which leads to an increase in seepage flow. As for the turbidity of the dam from 1 to 2 days after the dam earthquake, the preliminary analysis suggests that due to the earthquake, the dam rockfill body is squeezed and displaced, and the granules are broken and fine particles are formed, during rainfall and Under the action of seepage water, fine particles are taken out, which causes the seepage water to become turbid.

可能是地震激活的基岩裂隙所产生的裂隙水所致。由于地震作用，坝址处岩层原有的节理裂隙将产生振动、错位，导致原来岩层闭合的节理裂隙张开、增大、错位和贯通，形成渗流通道，从而导致渗流量增加。至于大坝震后的1~2 d 水质较震前浑浊原因，初步分析认为，由于地震作用，大坝堆石体受到挤压、错动，坝料颗粒间产生破碎形成细颗粒，在降雨和渗流水作用下，细颗粒被带出，从而导致渗流水质变混浊

Plot of leakage speed of water against time behind the dam

Although the seepage flow of the dam is still in the normal range compared with similar normal-operated dams at home and abroad, considering the seepage flow and the change of water quality are the most important indicators for judging the safety of the dam, it is recommended to strengthen the seepage of the dam in the future. Flow monitoring, paying special attention to the change of seepage water quality, and if necessary, physical and chemical analysis of sediment in seepage water to more accurately determine the source of seepage water.

尽管目前大坝的渗流量与国内外同类正常运行的大坝相比仍属正常范围，但考虑到渗流量及其水质变化是判别大坝安全性最重要的指标，建议今后加强大坝的渗流量监测，特别注意渗流水质的变化，必要时对渗流水中的沉淀物进行物理化学分析，从而更为准确地判别渗流水的来源。

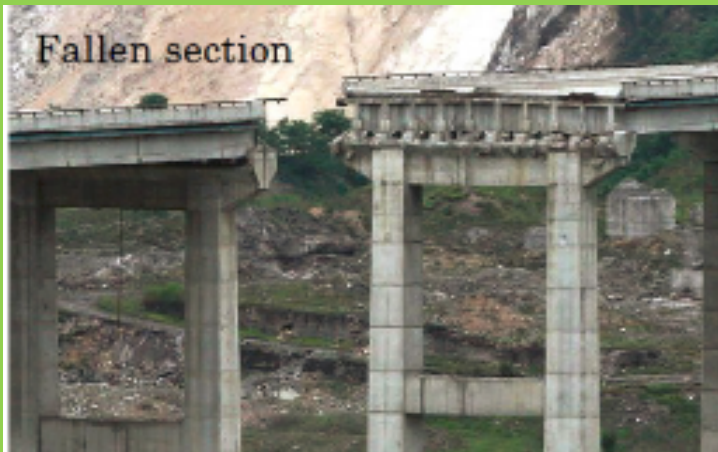
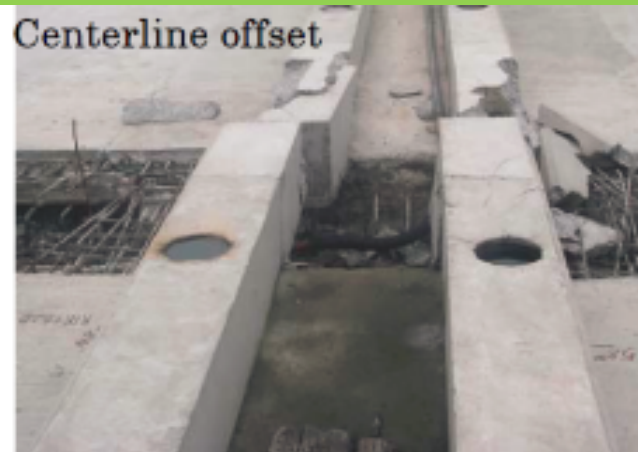
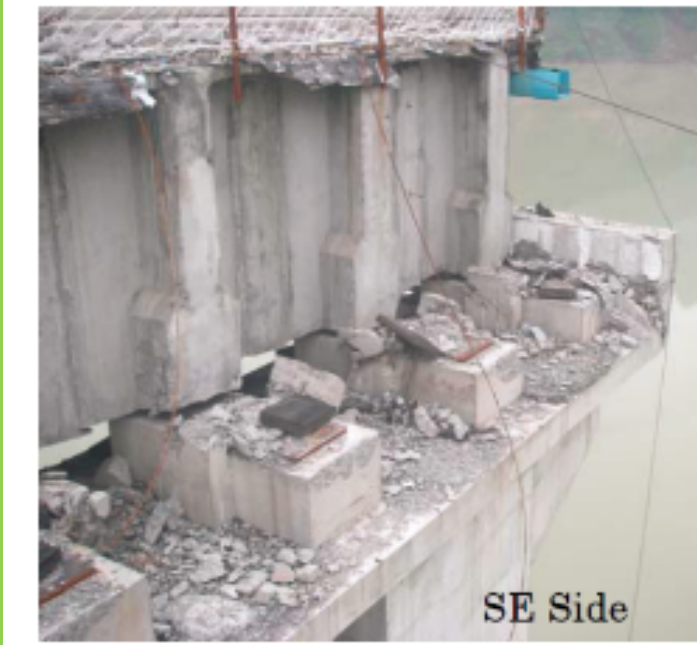
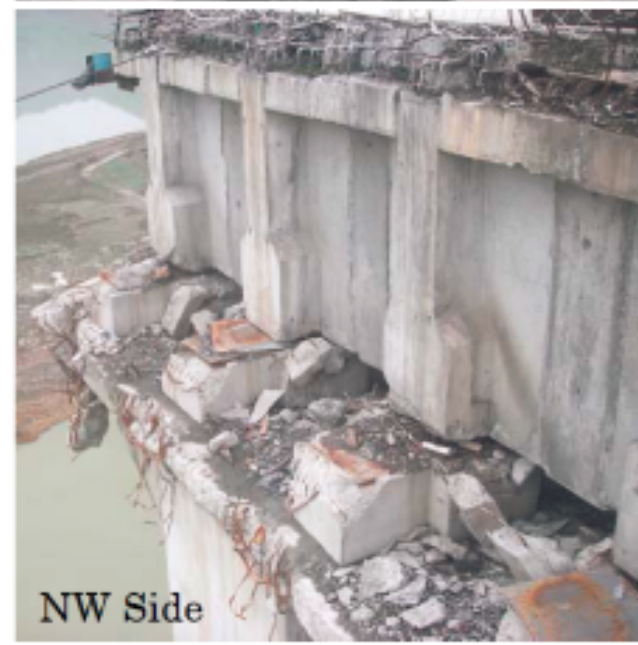
Miaziping bridge is 1436m long with a height of 100m, and has 19 approaches with T-girders. The earthquake caused the shifting of bridge girders longitudinally and laterally. One of the T-type girder approaches collapsed. The distance between piers was increased by more than 50cm and there were all-around fractures, spalling and bending cracks

米子坪桥长1436米，高100米。它有19种采用T型梁的方法。地震导致桥梁纵向和横向移动。其中一种T型梁的方法崩溃了。桥墩之间的距离增加了50多厘米，出现了全方位的裂缝，剥落和弯曲裂缝。

Views for the fallen sections of the Bridge
桥梁受损和倒塌的部分
