Meditating After Mege 2018 Conference and Site Visit: Geohazard and Damages To Zipingpu Reservoir Induced by Wenchuan Earthquake in China

**Mege 2018会议和实地考察后的沉思：
中国汶川地震引发紫坪铺水库的地质灾害和破坏**

By Ir. Raymond S. M. Chan 陈顺明

4 Geohazards and Damages Towards Zipingpu Dam 紫坪铺大坝的地质灾害和危害

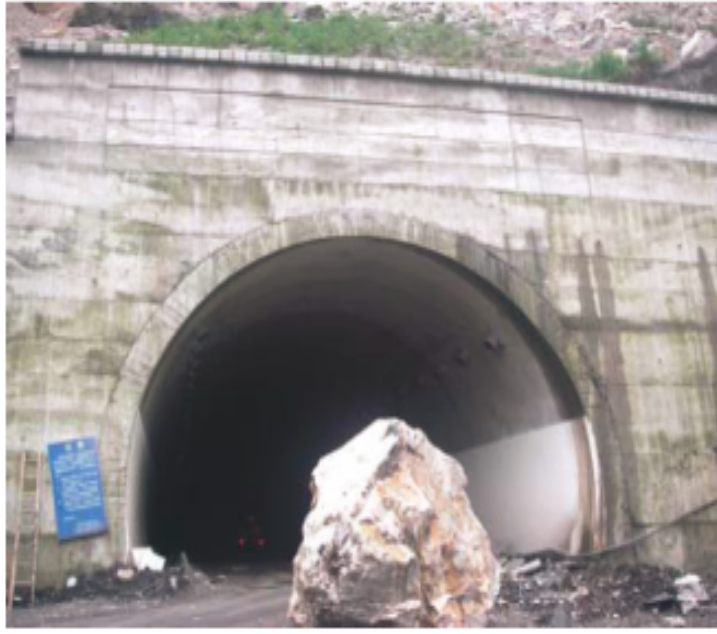
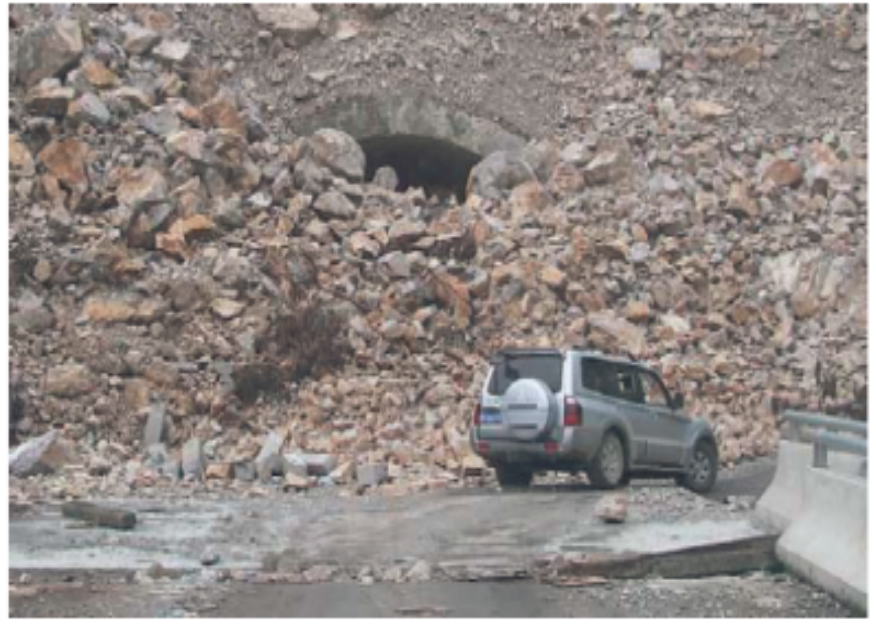
The two-lane tunnel nearby Zipingpu dam is 1km long, and the linings at several locations were damaged. The damaged sections of the tunnel were re-bolted and shotcreted.

紫坪铺大坝附近的双车道隧道长1公里，多个地点的衬砌受损。隧道的受损部分重新喷浆。

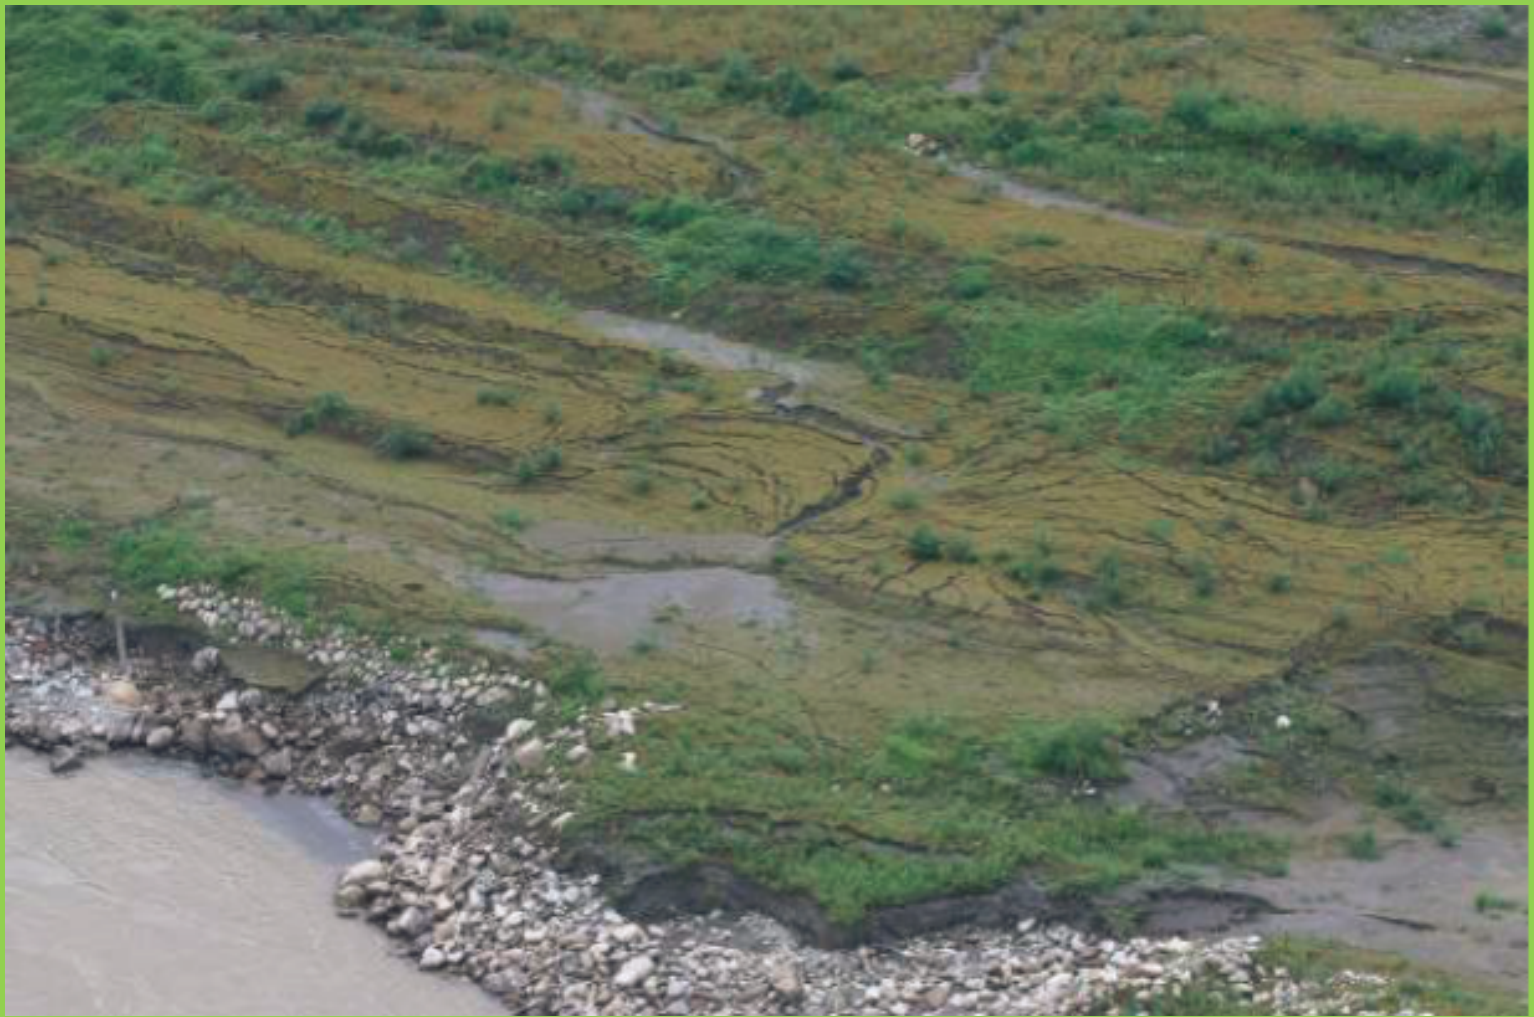
After the Zipingpu Reservoir was emptied, the upstream reservoir was at the bottom of the Minjiang River. The liquefaction side collapsed in the mud and sand part of the beach land.

紫坪铺水库排空后，上游水库位于岷江底部。在滩地的泥沙部分发生液化塌陷现象。

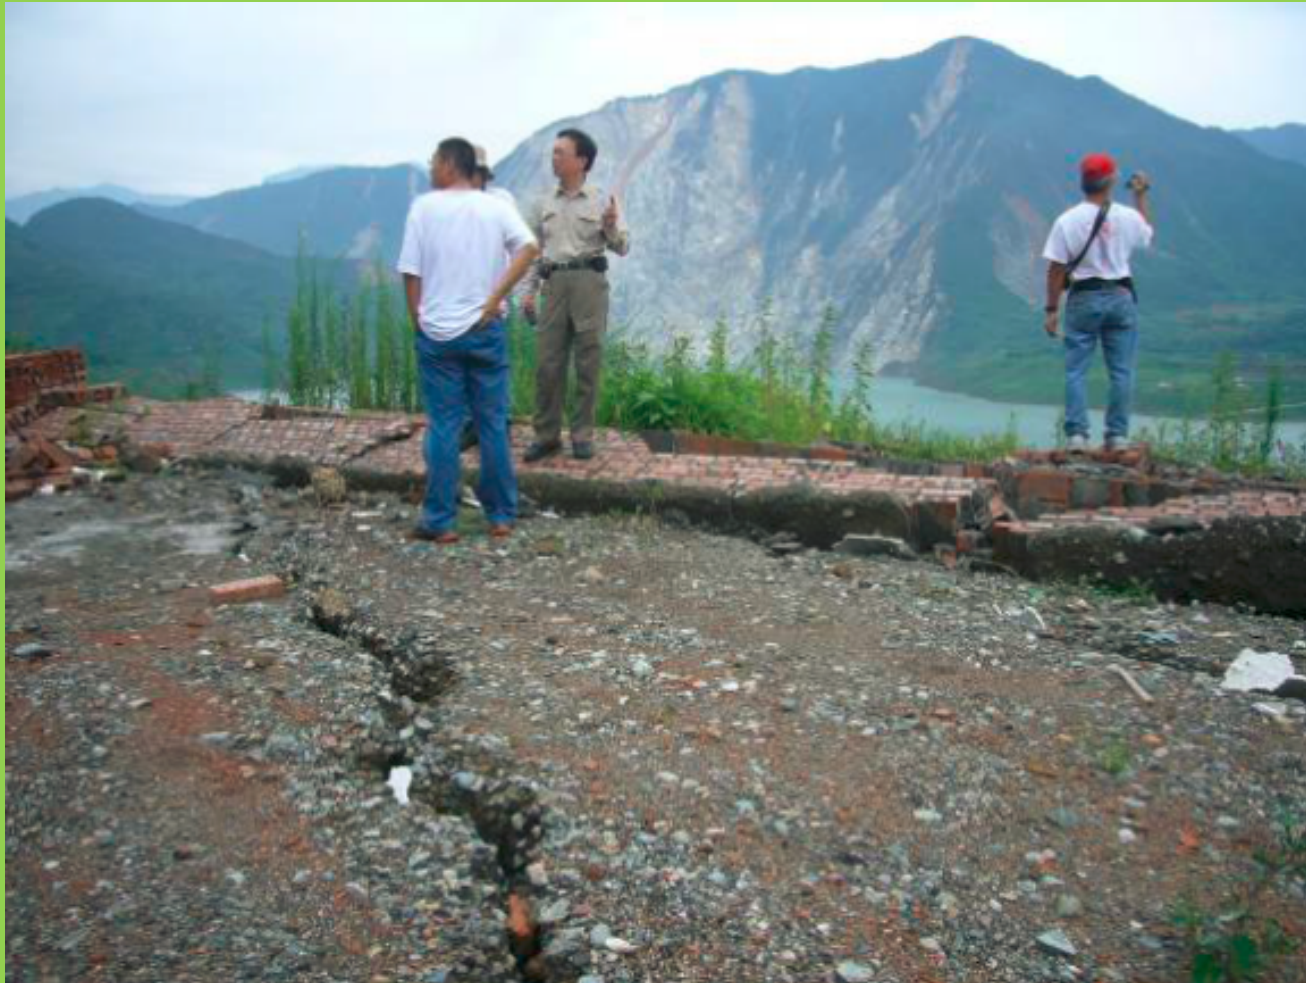
The right bank of the Minjiang River near Miaoziping of the Zipingpu Reservoir was cracked due to the earthquake
紫坪铺水库庙子坪附近岷江右岸受地震影响龜裂

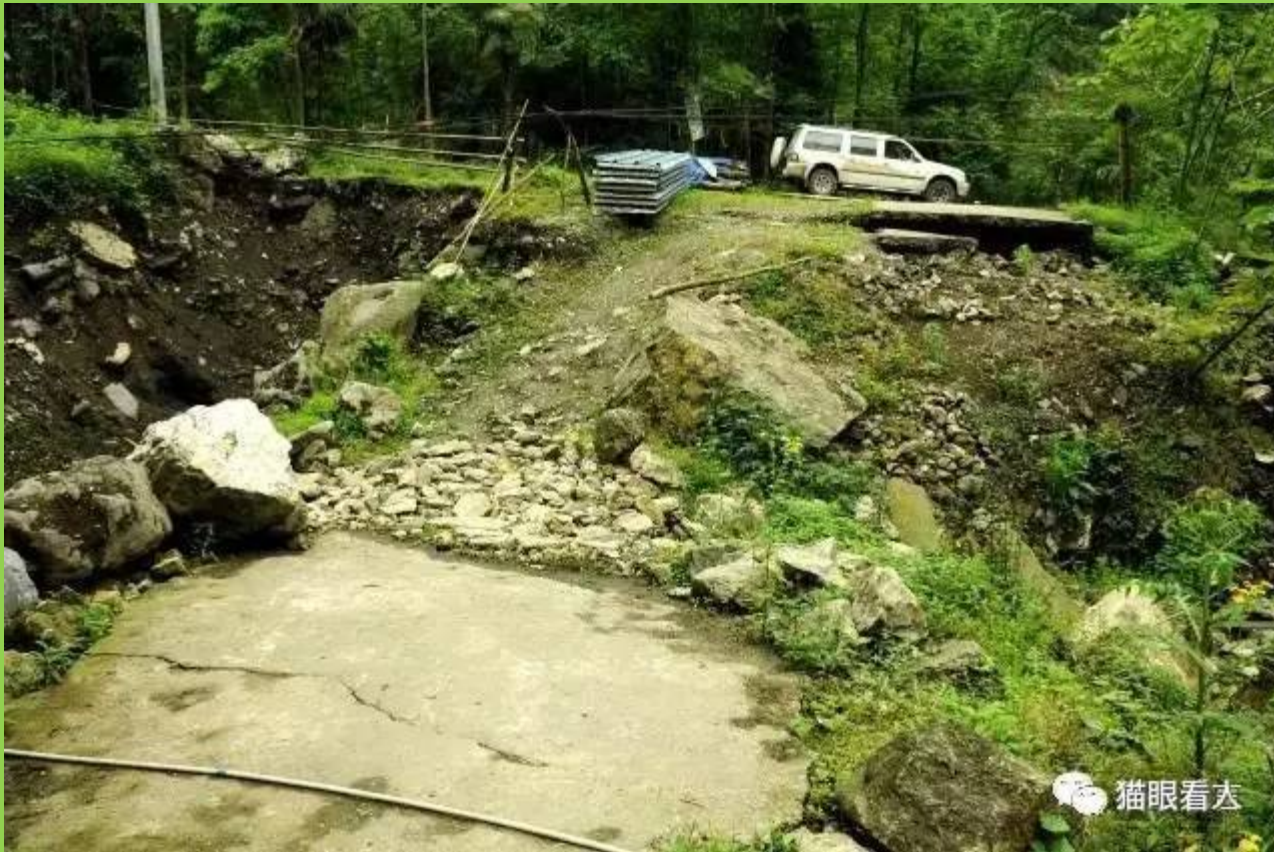
Through the surface rupture zone formed by the Shuimo-Miaoziping fault in the Zipingpu Reservoir in the Wenchuan earthquake, the road was broken, and the vertical and horizontal displacements reached about 5 meters.

通过紫坪铺水库的水磨-庙子坪断裂在汶川地震中形成的地表破裂带，公路被错断，垂直和水平位移均达到5米左右。

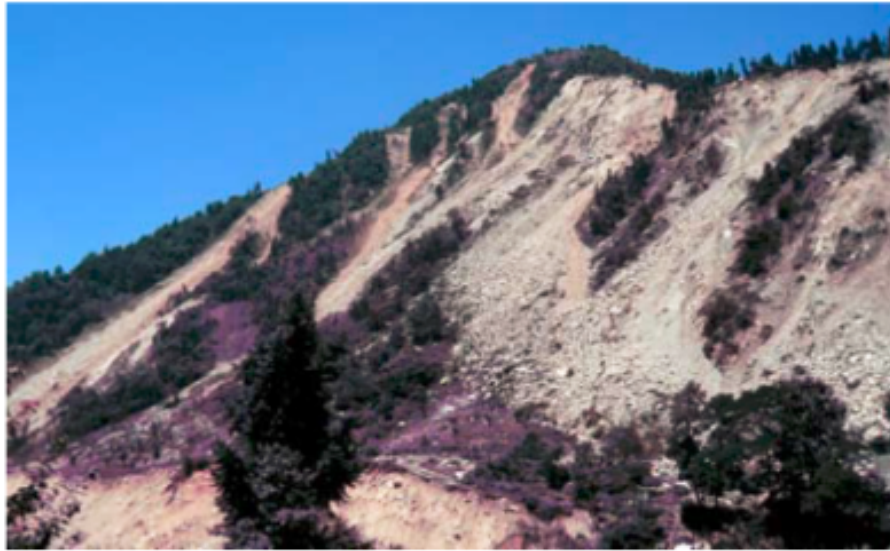
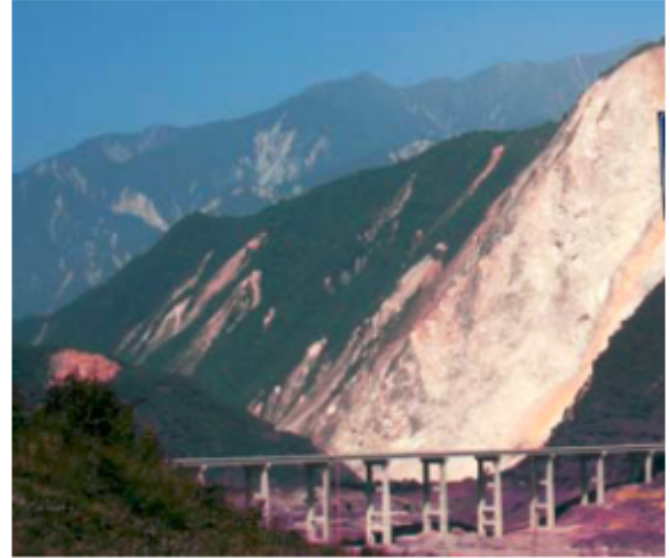
Several surficial slope failures in limestone unit in the vicinity of the Weizhou and the Zipingpu dam site. The surficial slope failures in limestone unit was spectacular and continued for several kilometers as they are clearly observed in satellite images.

紫坪铺坝址附近石灰岩单元的几处表层边坡破坏。石灰岩单元的表层斜坡破坏是壮观的，持续了几公里，因为它们在卫星图像中清晰可见。

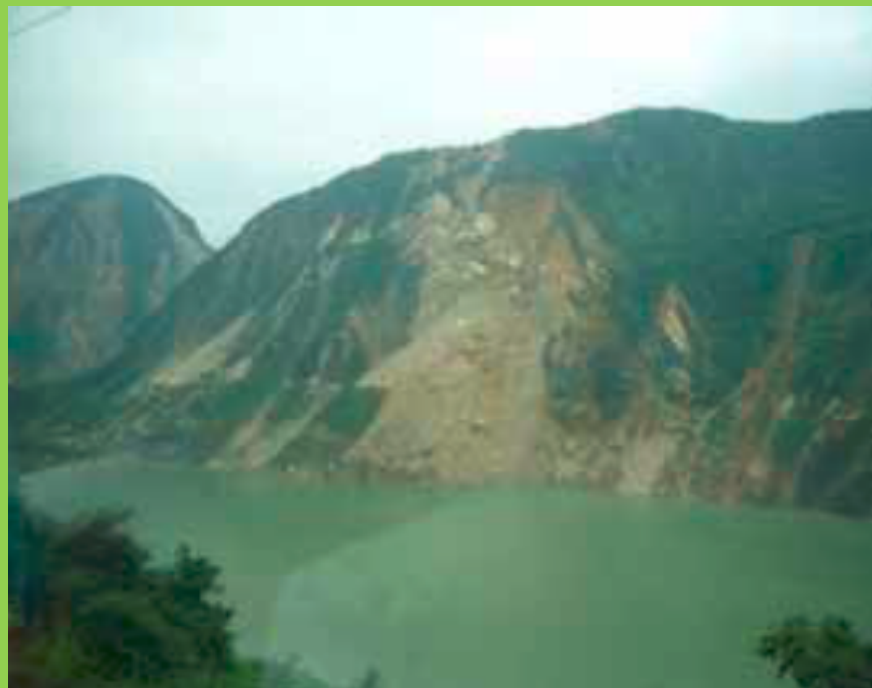
At the upper reaches of the Zipingpu Reservoir, the peeling type (shallow layer) debris flows on the left bank of the Minjiang River. The debris channels occurred mostly at the top of the slope or the upper sections of the slopes, which are one of the characteristics of earthquake collapse.

在紫坪铺水库上游，岷江左岸有剥离型（浅层）泥石流。碎片通道主要发生在斜坡顶部或斜坡上部，这是地震坍塌的特征之一。

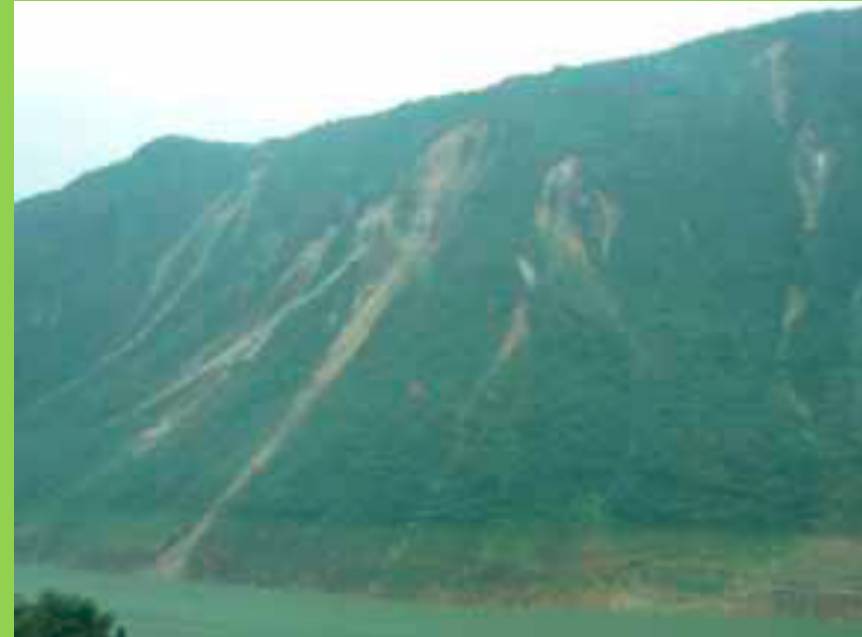
The dense network of anchors protected the slopes but those slopes without anchoring works were severely collapsed.

密集的锚网络 护了斜坡，但那些没有锚固工程的斜坡严重坍塌。

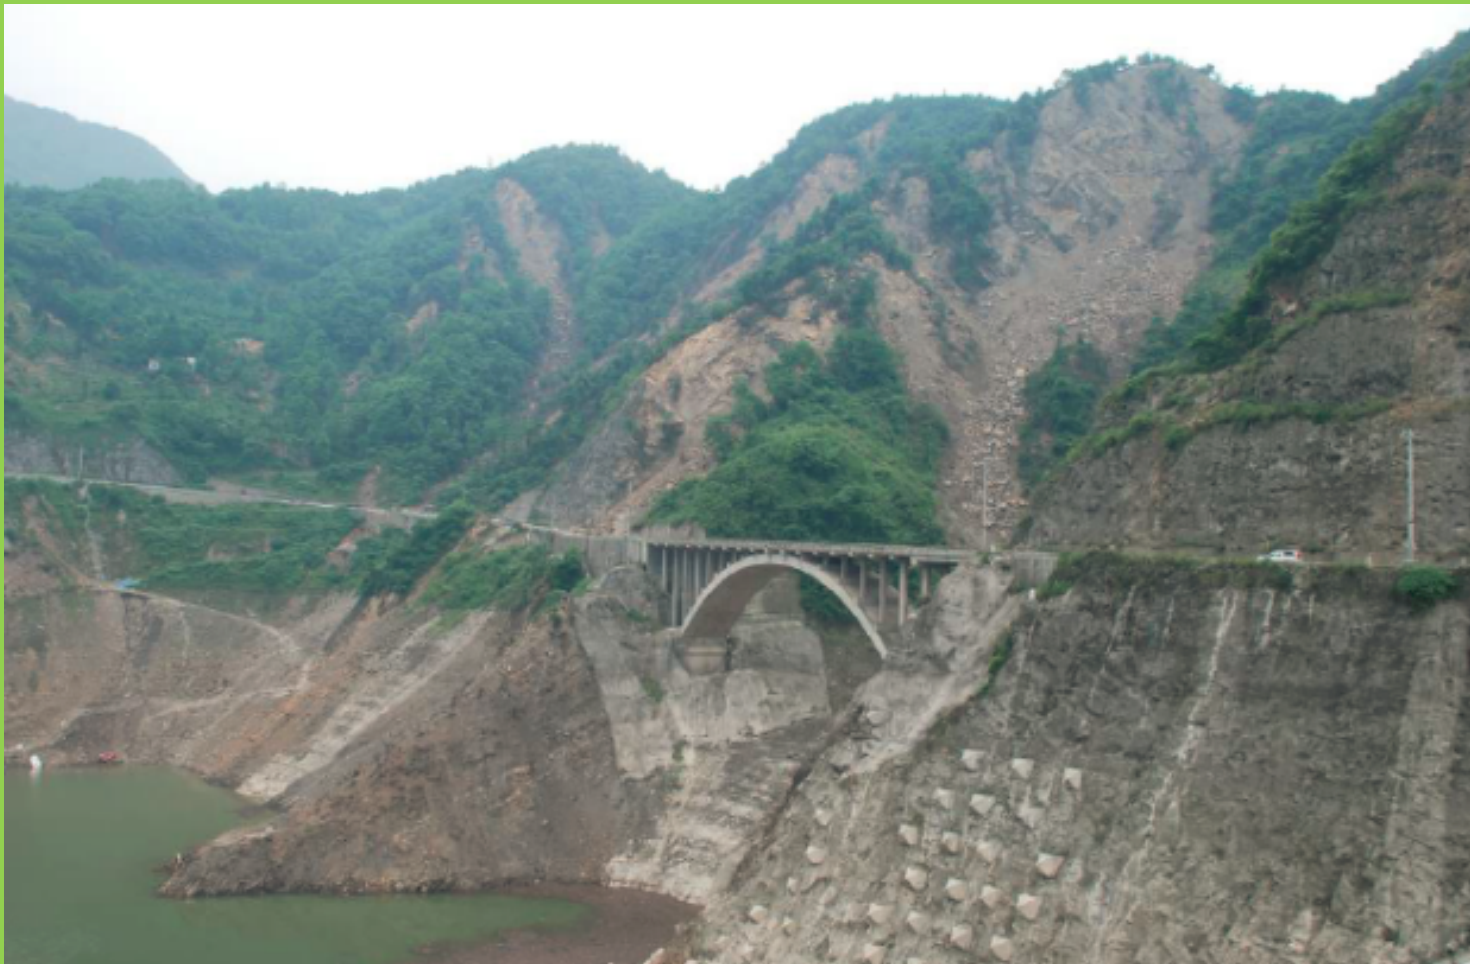
Landslide view on the slopes of the reservoir 200 meters from the crest of the dam

水库斜坡上的山体滑坡景观距离大坝顶部200米

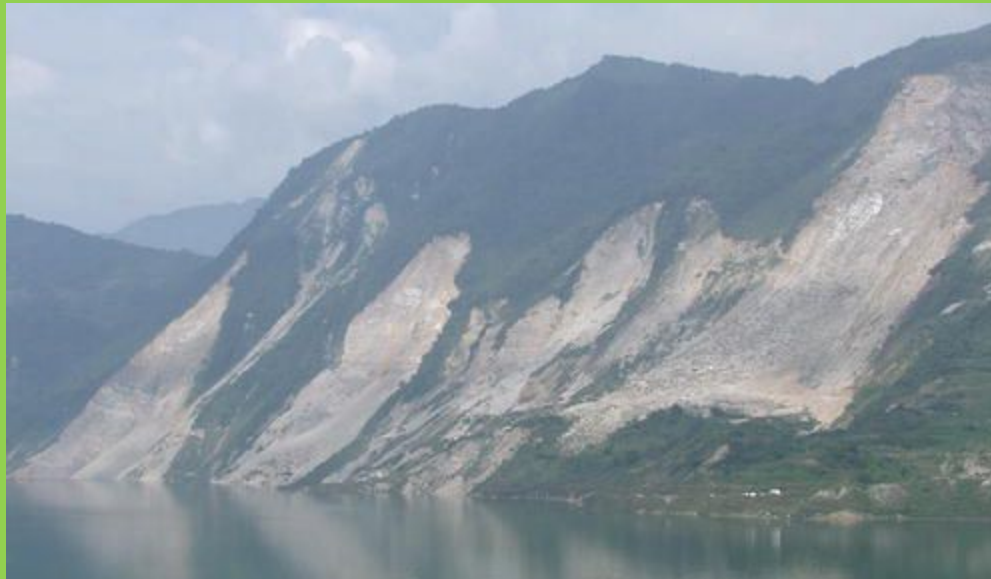
Slopes next to Zipingpu Reservoir were collapsed due to the Wenchuan earthquake

由于汶川地震，紫坪铺水库水库旁边的斜坡坍塌

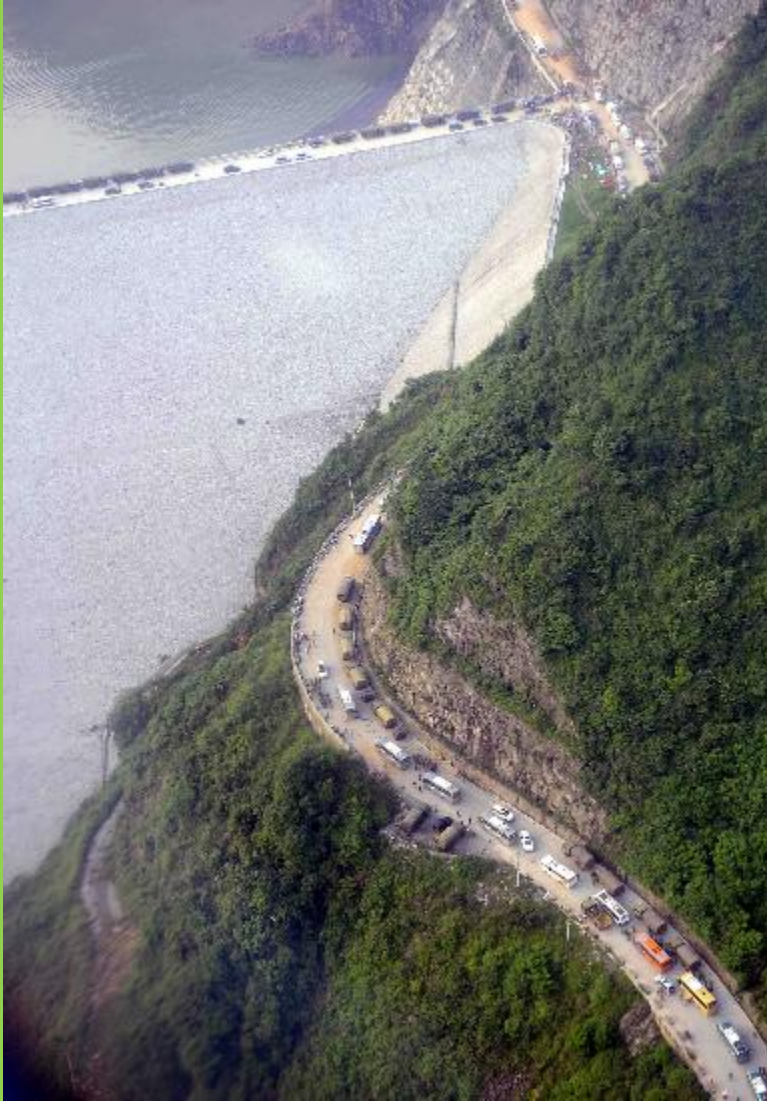
Serious road traffic
congestion near
Zipingpu Dam after the
earthquake

地震后紫坪铺大坝附近 路
交通受阻 况
