Meditating After Mege 2018 Conference and Site Visit: Geohazard and Damages To Zipingpu Reservoir Induced by Wenchuan Earthquake in China

**Mege 2018会议和实地考察后的沉思：
中国汶川地震引发紫坪铺水库的地质灾害和破坏**

By Ir. Raymond S. M. Chan 陈顺明

4 Geohazards and Damages Towards Zipingpu Dam 紫坪铺大坝的地质灾害和危害

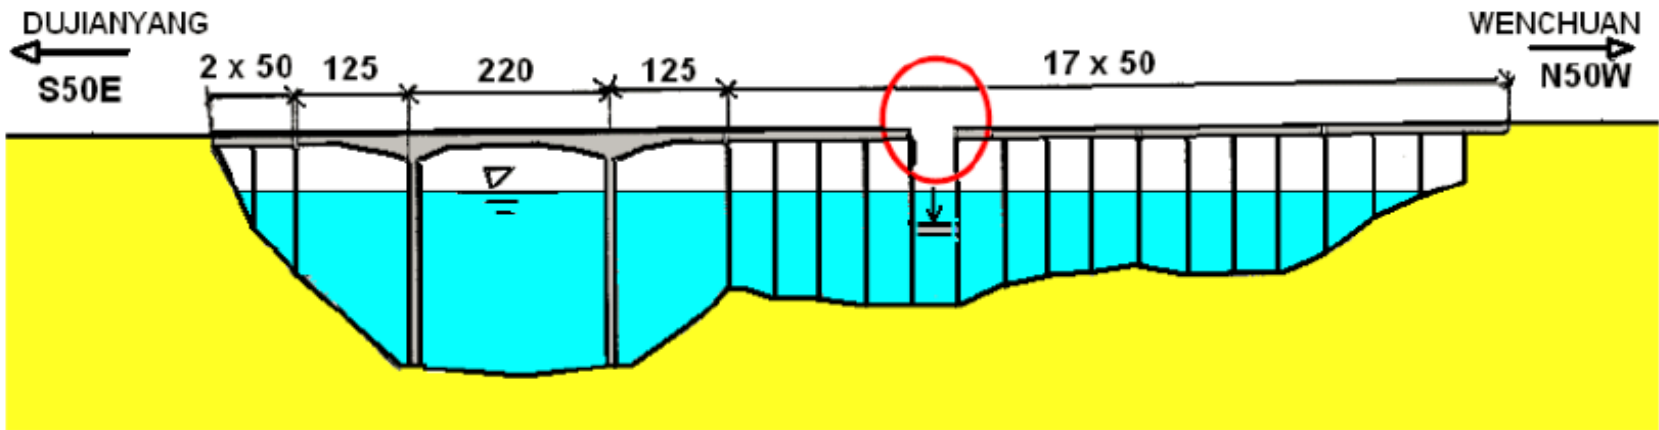
Miaziping bridge is 1436m long with a height of 100m, and has 19 approaches with T-girders. The earthquake caused the shifting of bridge girders longitudinally and laterally. One of the T-type girder approaches collapsed. The distance between piers was increased by more than 50cm and there were all-around fractures, spalling and bending cracks

米子坪桥长1436米，高100米。它有19种采用T型梁的方法。地震导致桥梁纵向和横向移动。其中一种T型梁的方法崩溃了。桥墩之间的距离增加了50多厘米，出现了全方位的裂缝，剥落和弯曲裂缝。

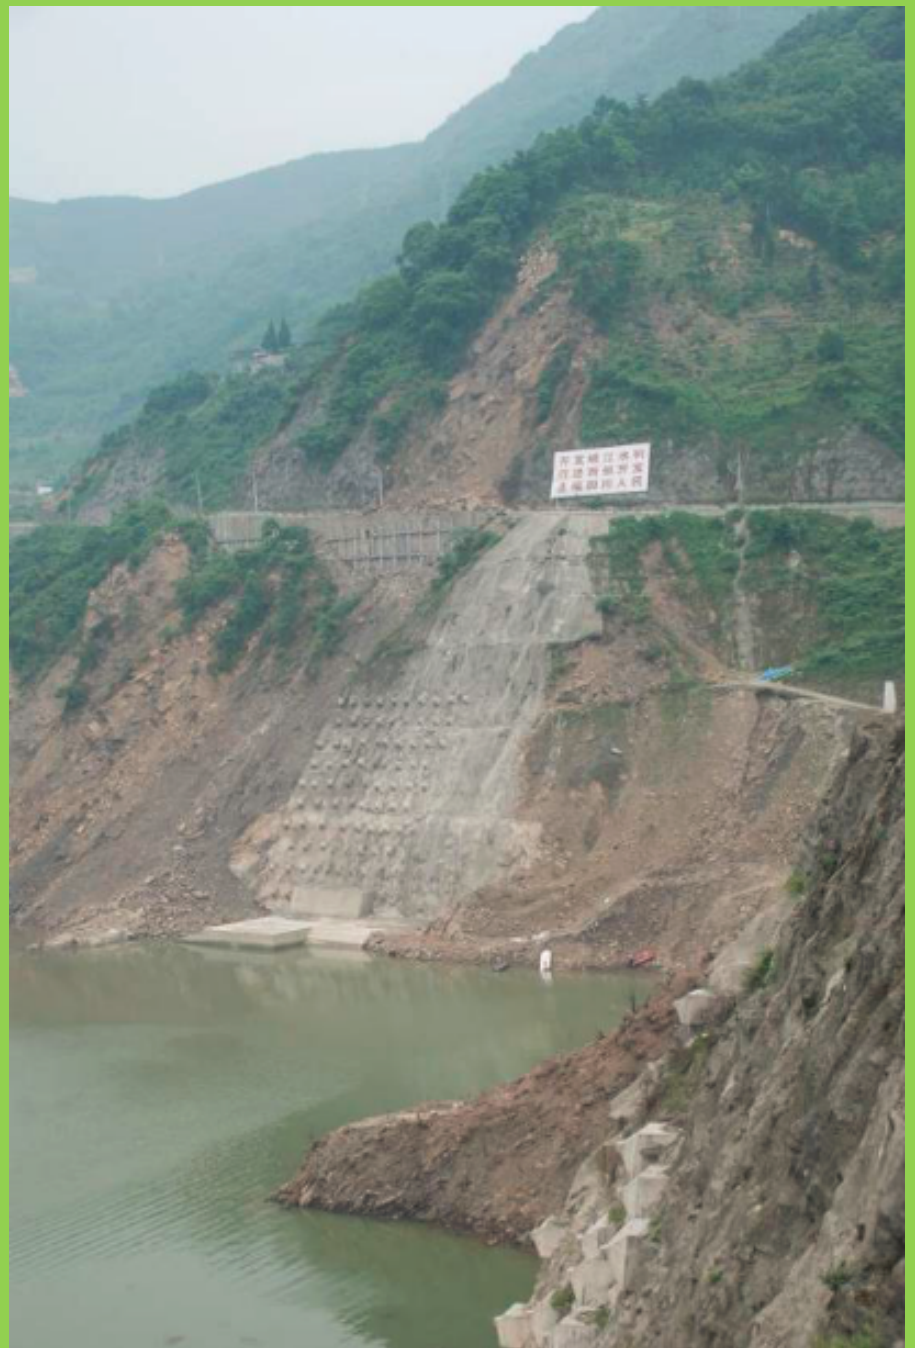
The dense network of anchors protected the slopes but those slopes without anchoring works were severely collapsed.

密集的锚网络 护了斜坡，但那些没有锚固工程的斜坡严重坍塌。

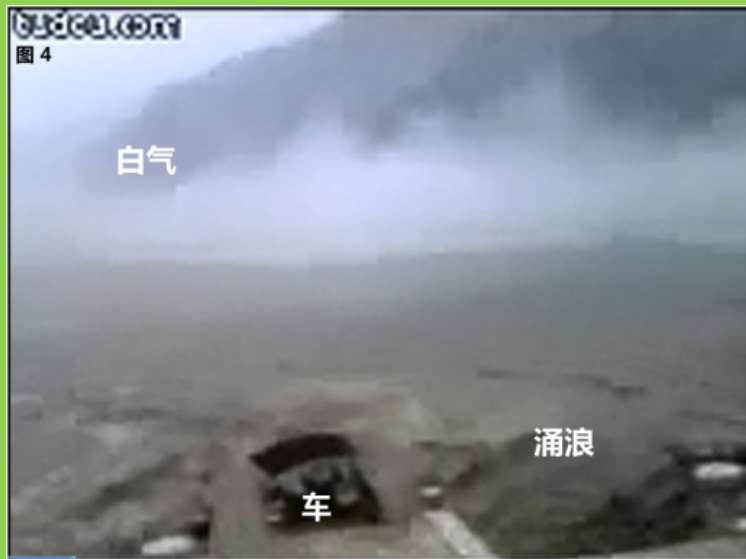
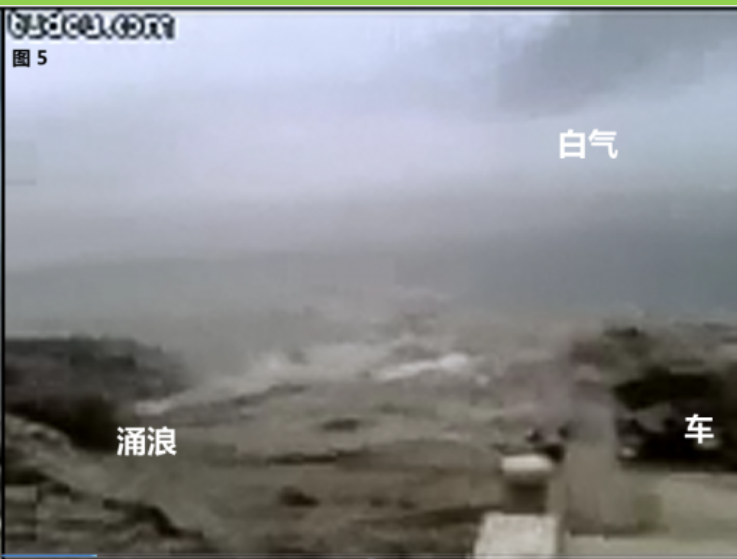
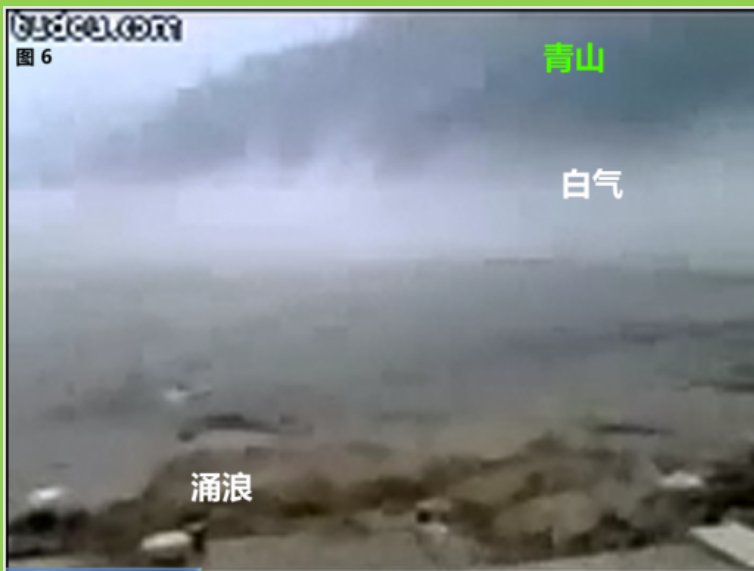
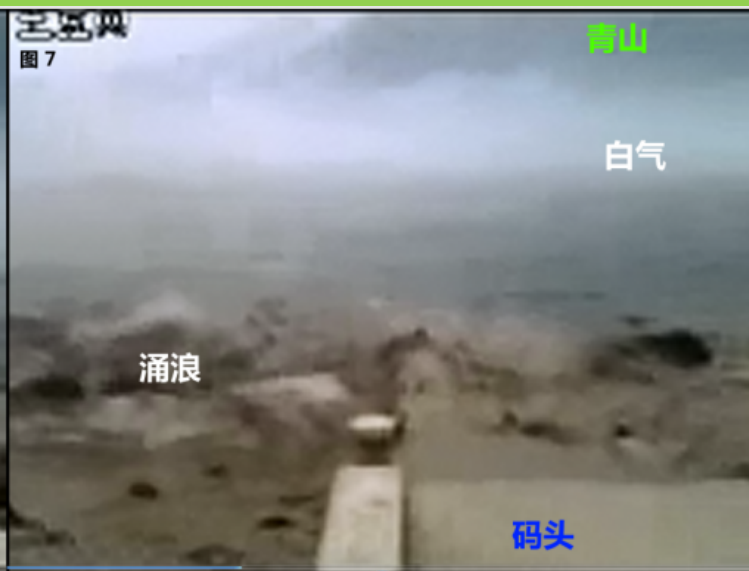
在汶川大地震后，紫坪铺大坝管理人员说：**地震引起的水库浪将在库边钓鱼的人卷入库水中！**住在紫坪铺大坝旁的一位先生说，他的儿子是在紫坪铺钓鱼时，被震时的大浪卷走了。一位从汶川县映秀镇逃难出来的男子说：“**地震时，我看见紫坪铺水库的水位猛涨，还看见山上的村庄在泥石流中瞬间消失，场景十分可怕！**”汶川大地震造成的紫坪库水库的湖啸，还可能导致了213国道从紫坪铺水库到映秀的一段大桥的跨倒

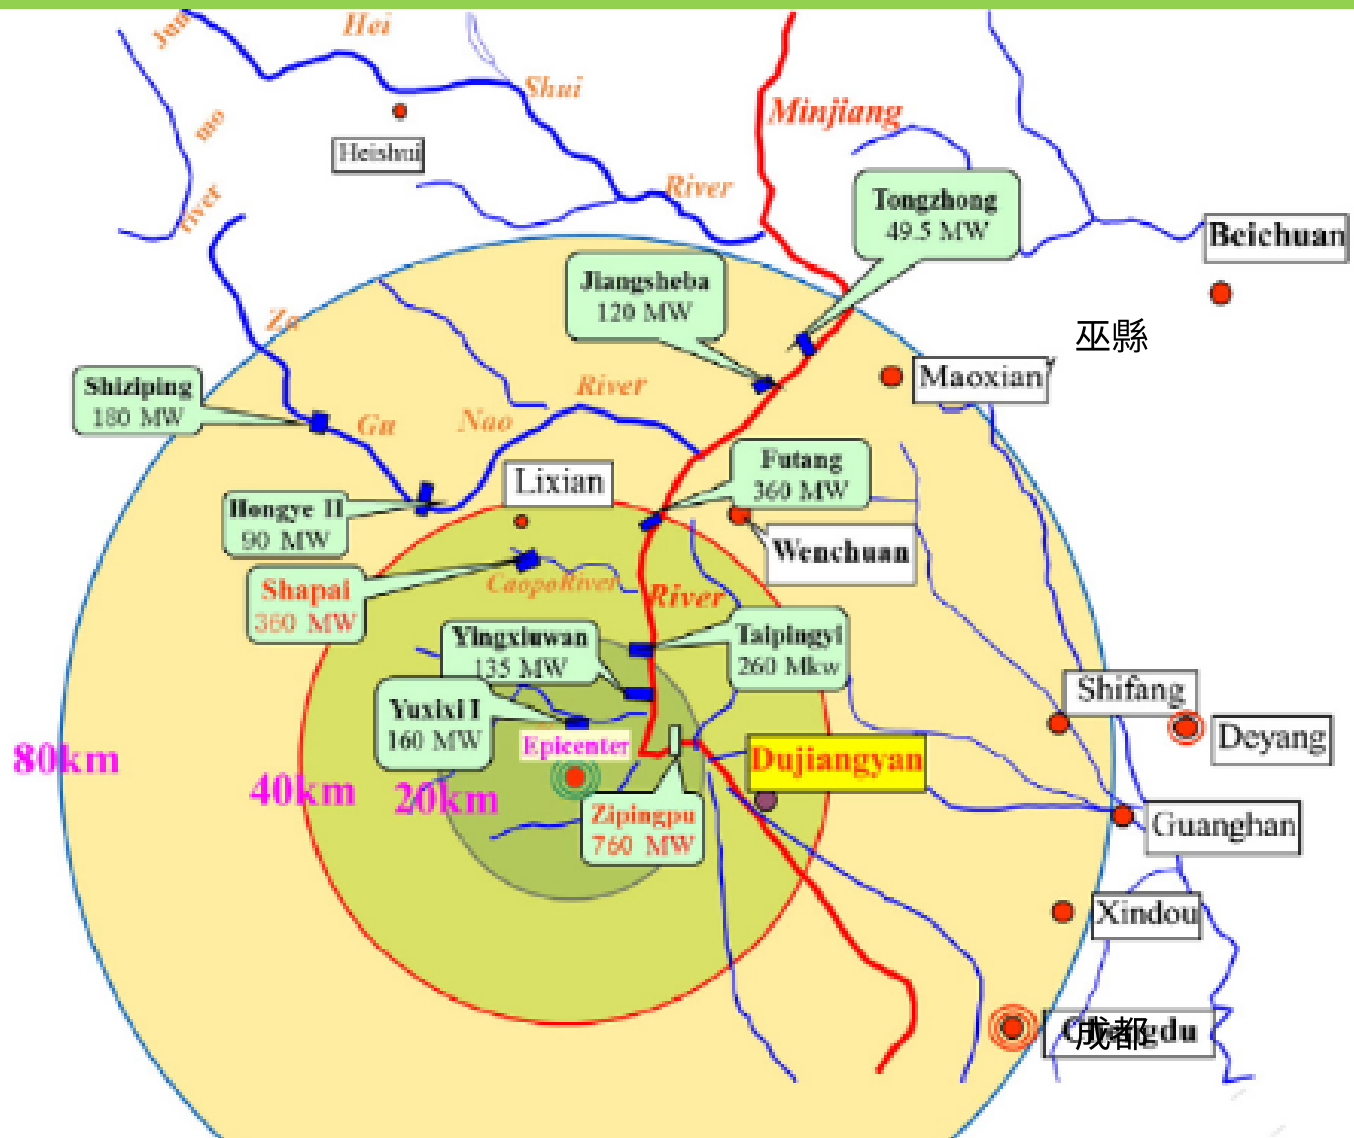
Fig. 2. Major earthquake impacts on the Minjiang river power station.

Major Earthquake Impact on Dams with Power Stations Around Minjiang River
地震对岷江流域电站大坝的主要影响
